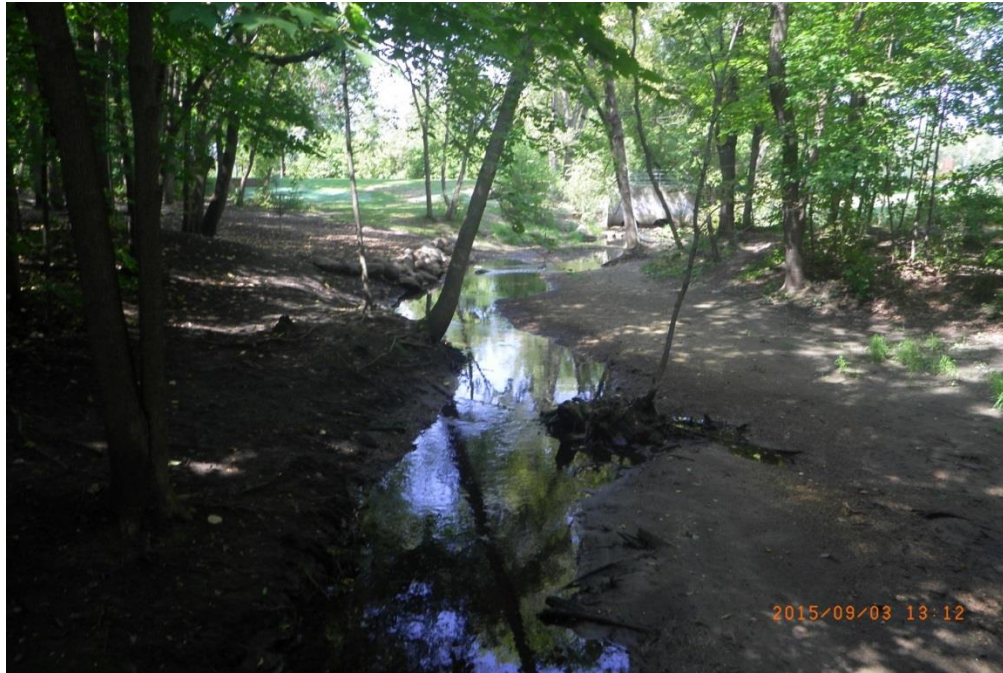
**Photo 1.** *Site 1.* Historic meander in right overbank (photo is looking upstream)

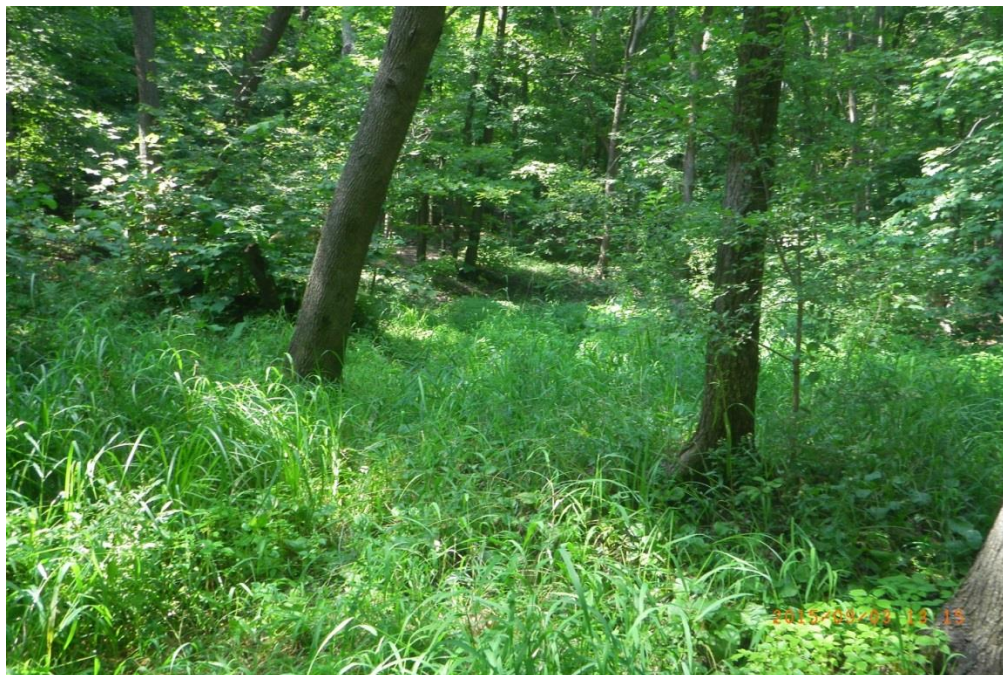
**Photo 2.** *Site 2.* Historic meander

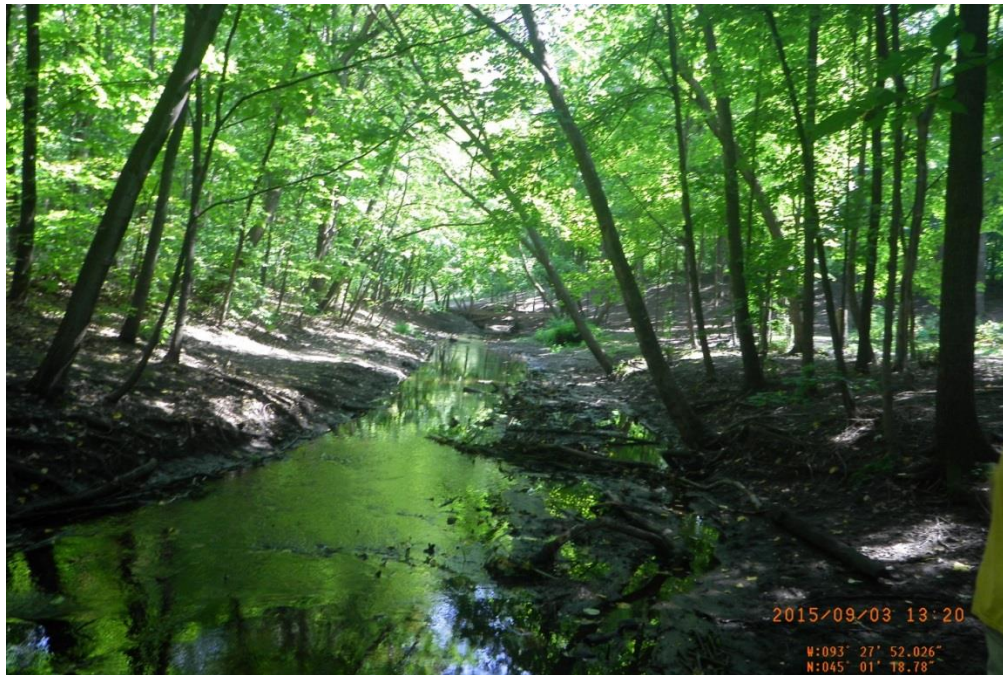
**Photo 3.** *Site 3.* Over-widened stream reach

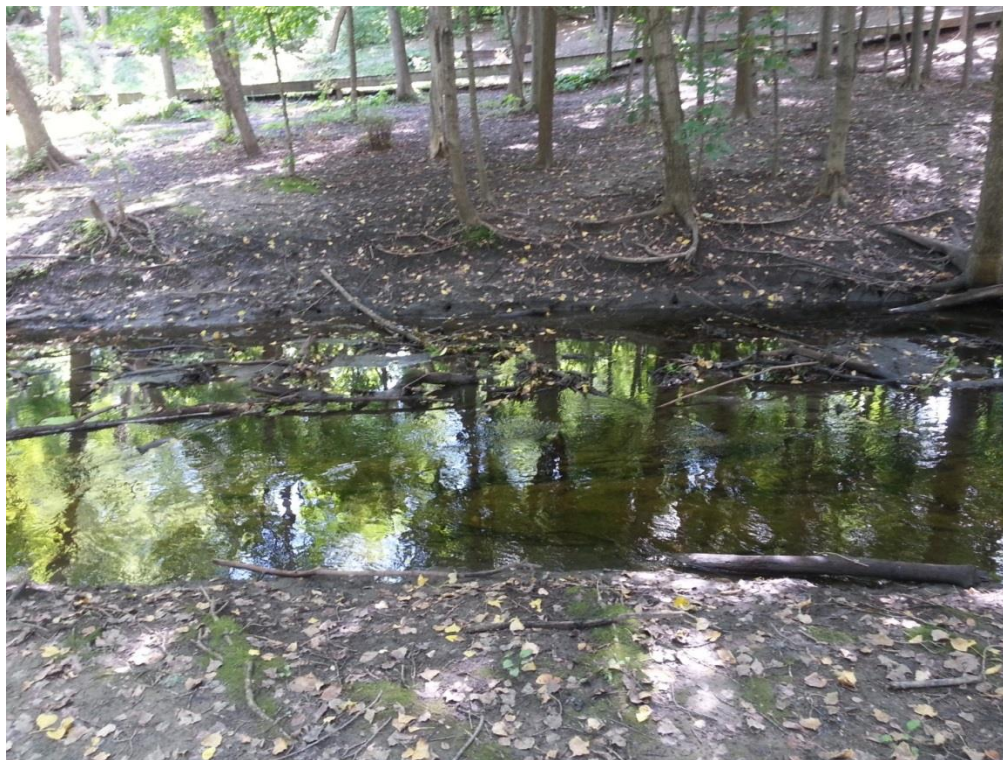
**Photo 4.** *Site 4.* Unvegetated overbanks contributing to stream

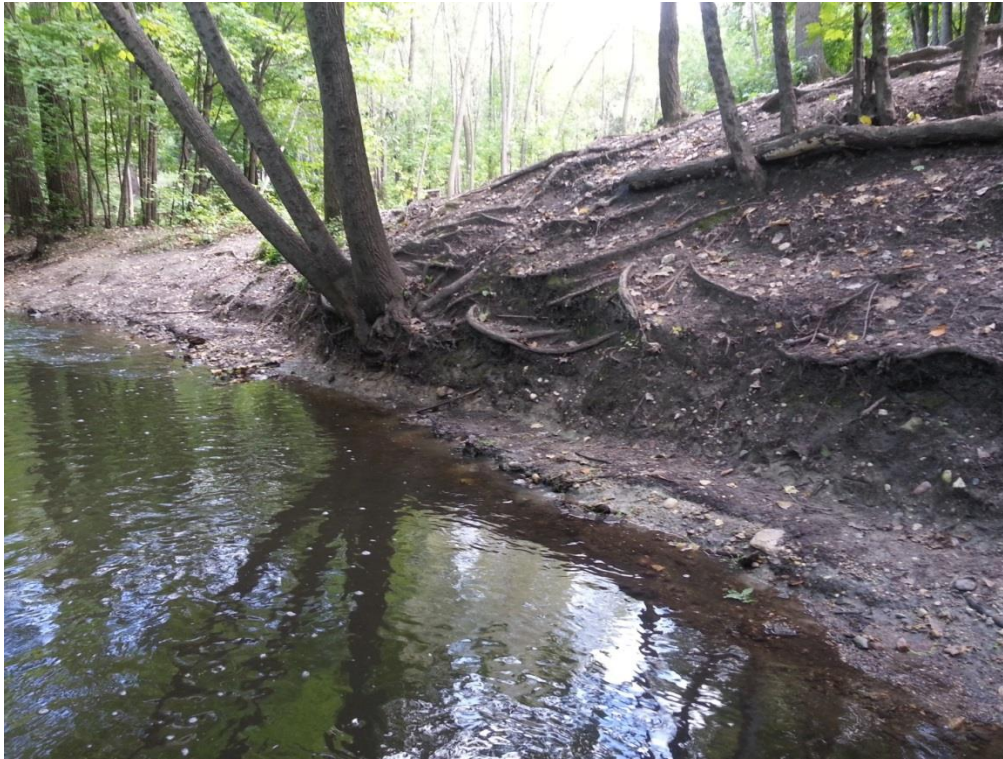
**Photo 5.** *Site 5.* Minor to moderate erosion on steep bank

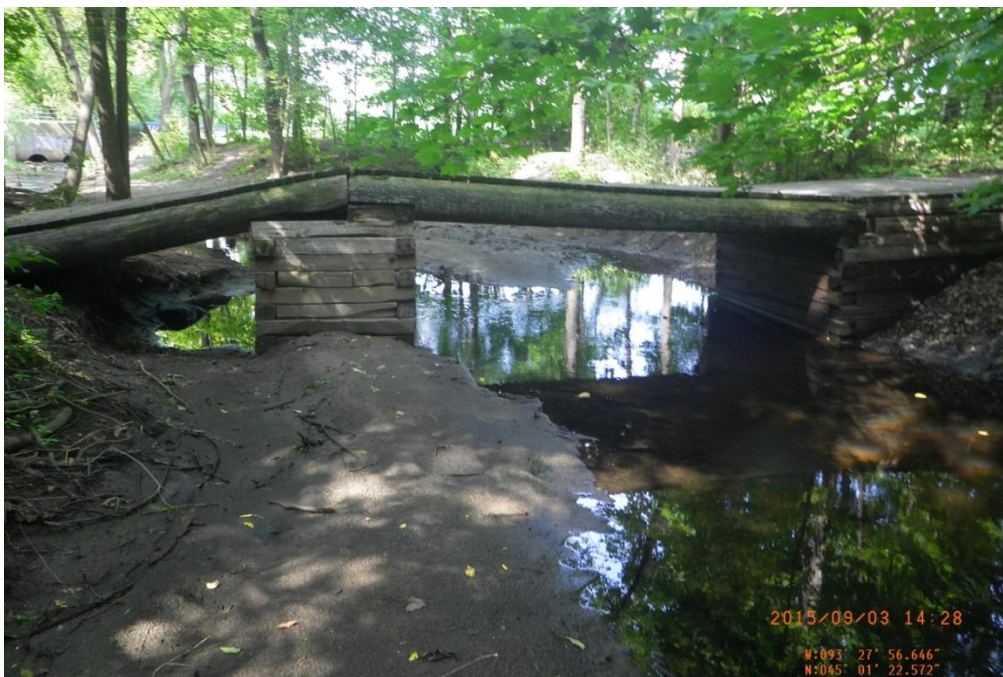
**Photo 6.** *Site 6.* Erosion around bridge abutments

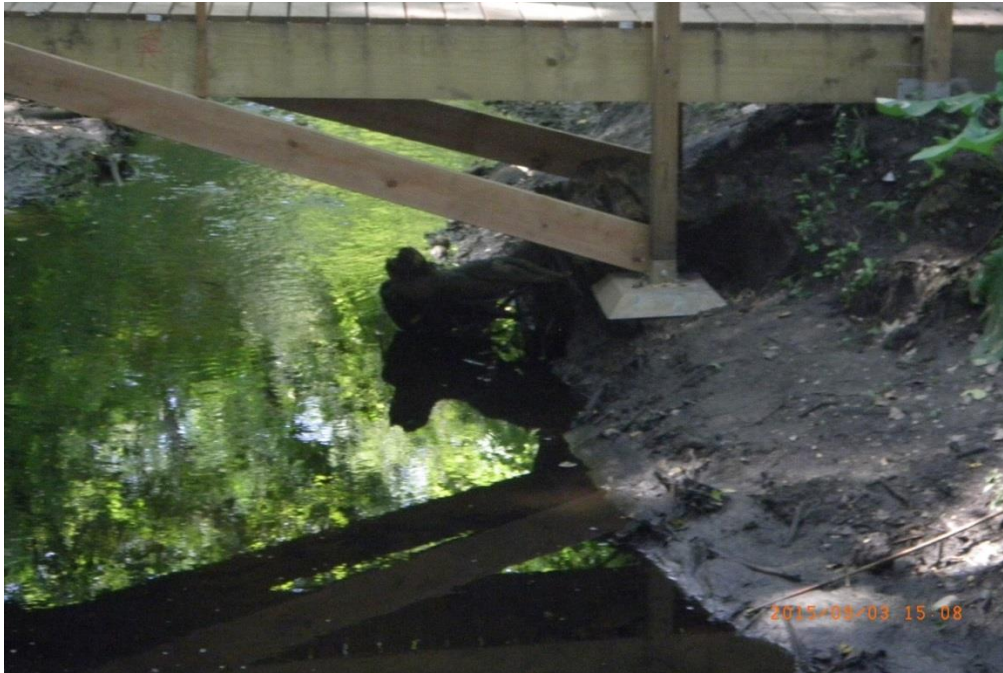
**Photo 7.** *Site 8.* Erosion around bridge abutments

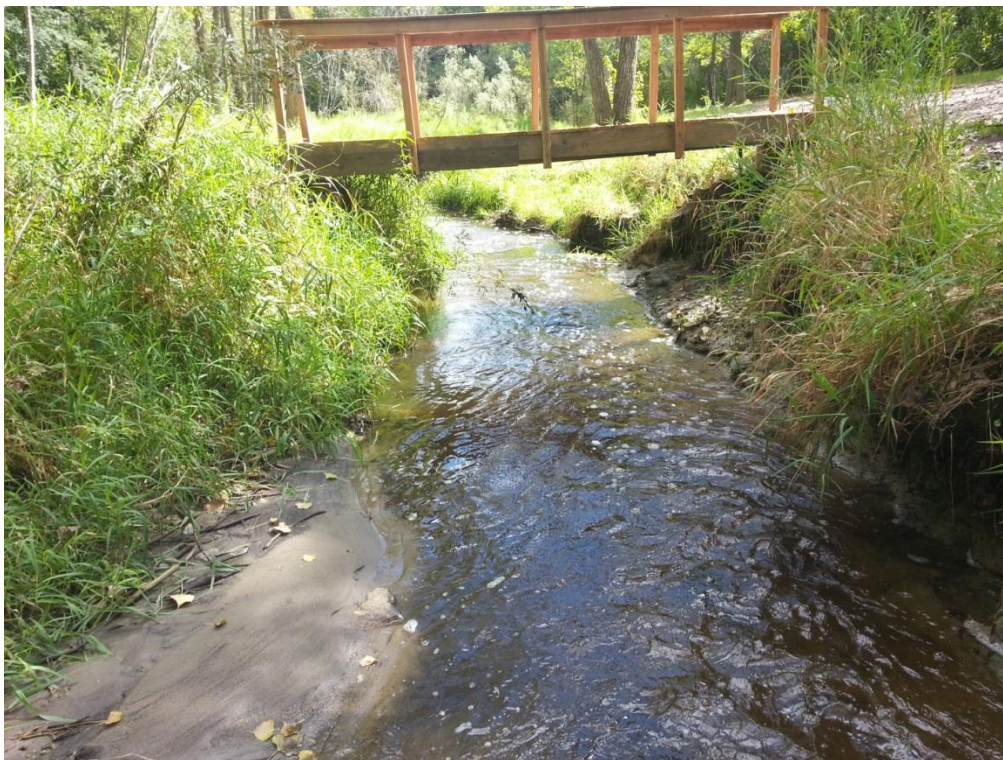
**Photo 8.** *Site 9.* Erosion around bridge abutments

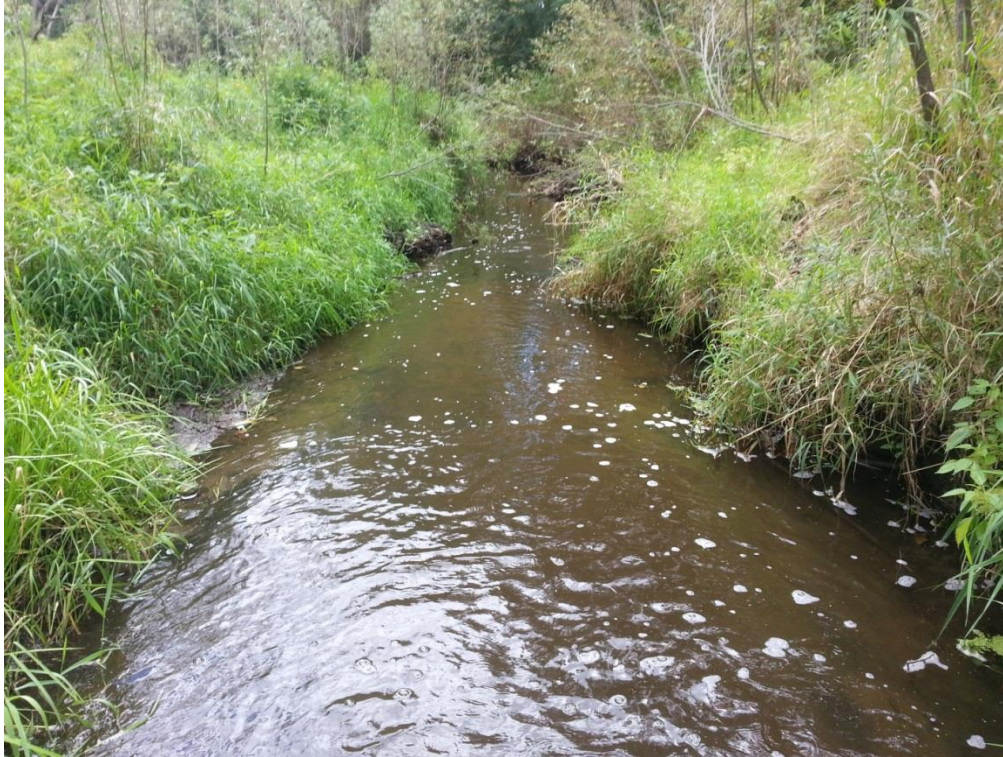
**Photo 9.** *Site 10.* Incised stream bed

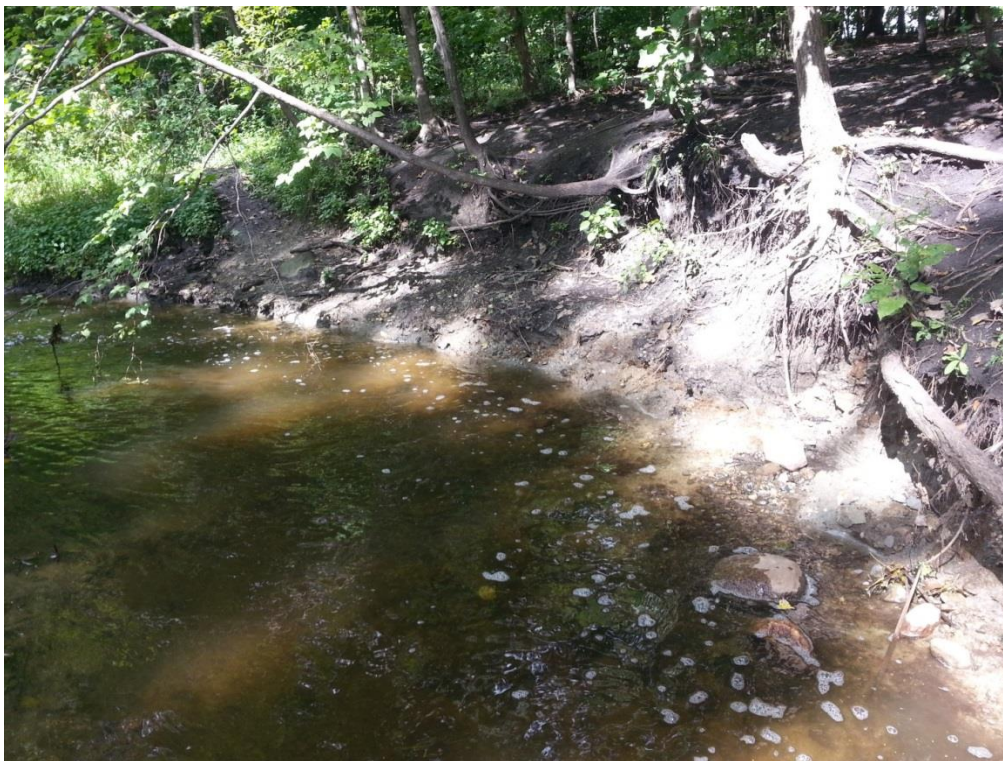
**Photo 10.** *Site 11.* Minor to moderate erosion on outside of bank meander

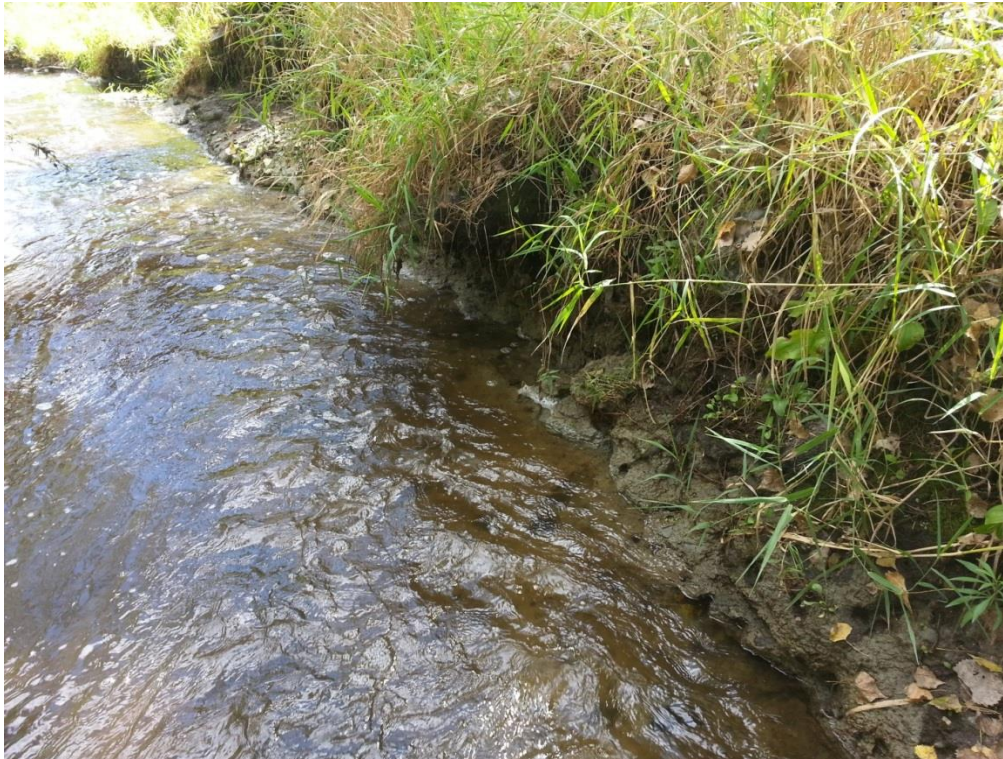
**Photo 11.** *Site 12.* Minor to moderate erosion on stream bank

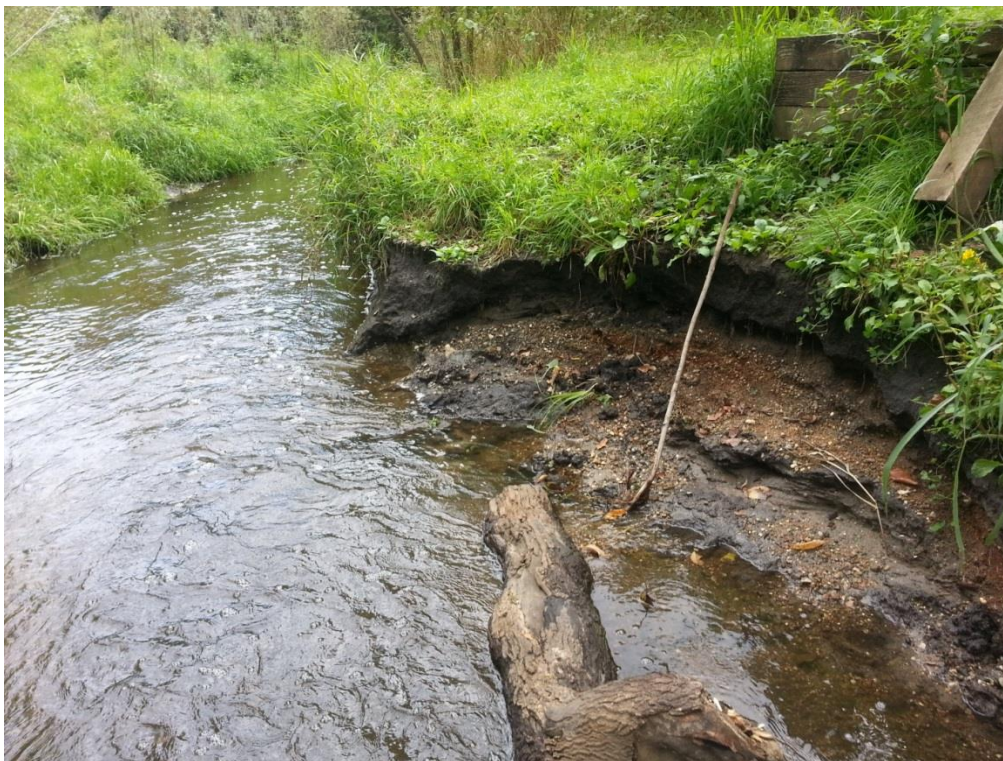
**Photo 12.** *Site 13.* Minor to moderate erosion on outside of bank meander

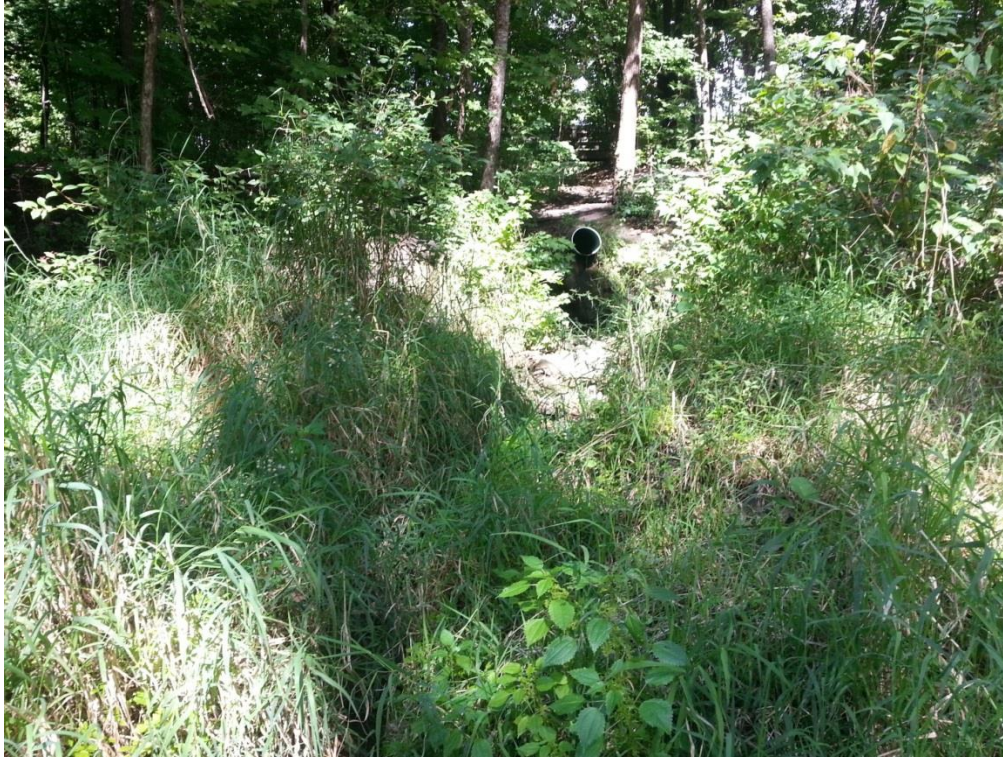
**Photo 13.** *Site 14.* Eroded culvert outfall

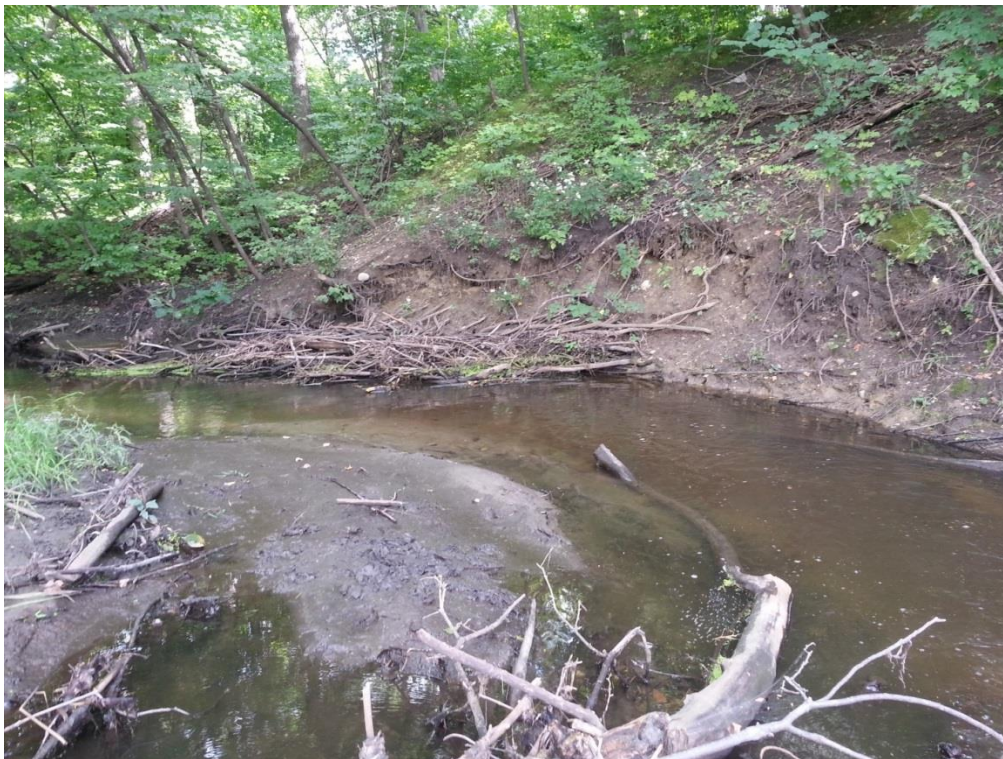
**Photo 14.** *Site 15.* Minor to moderate erosion on outside of stream bend

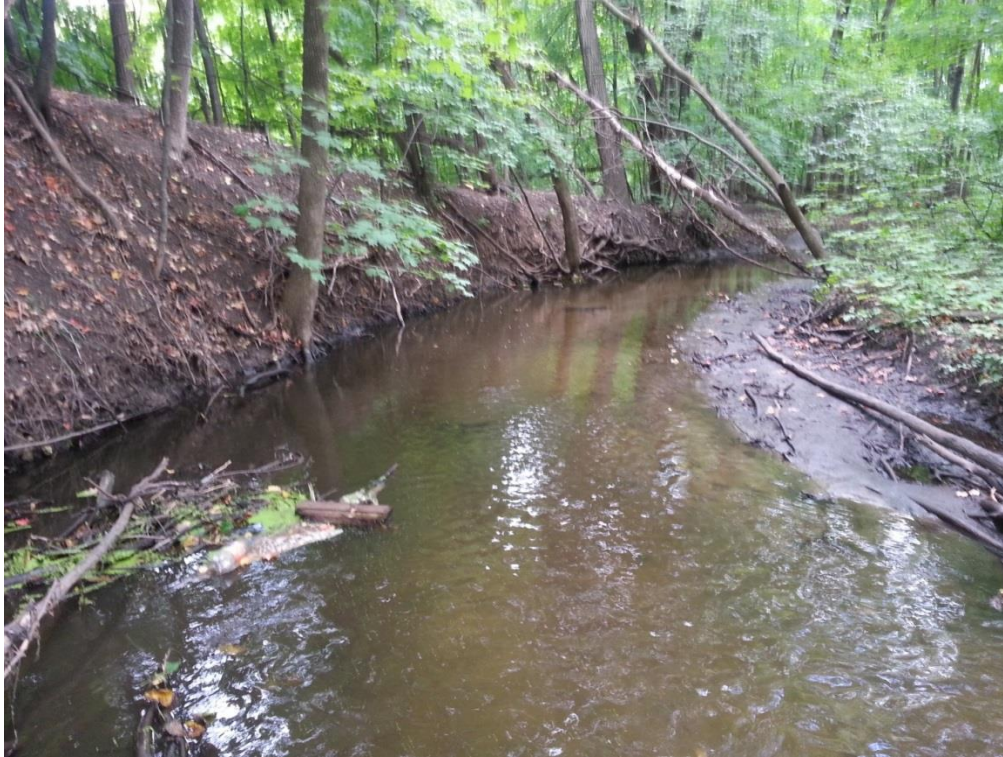
**Photo 15.** *Site 16.* Significant erosion on outside of stream bend

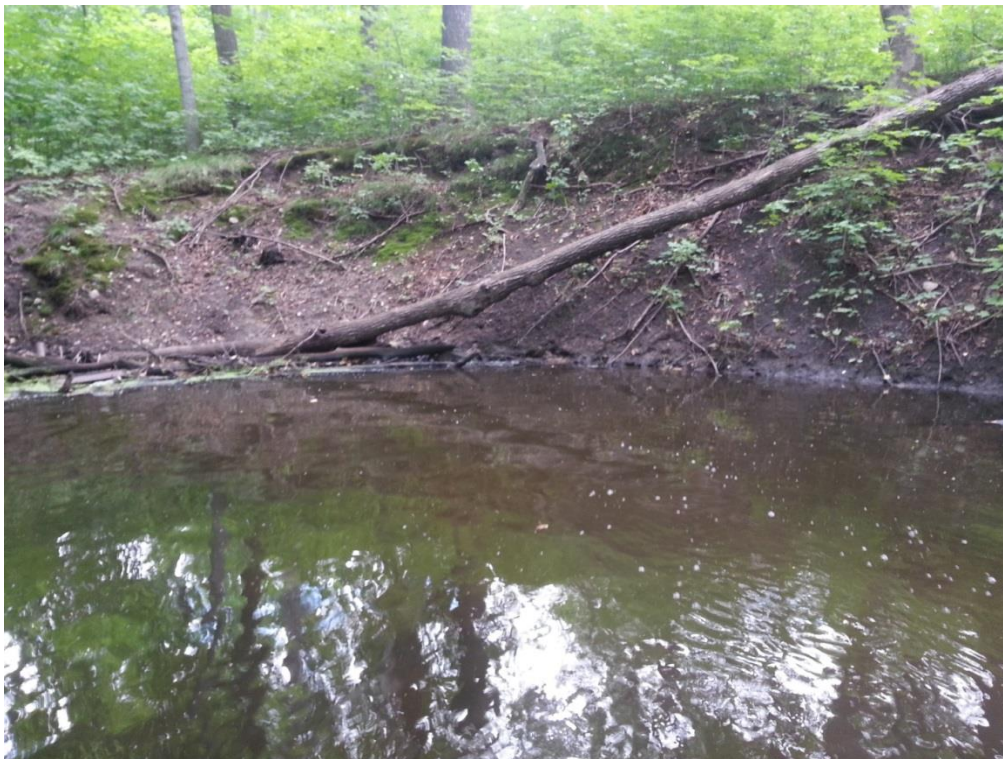
**Photo 16.** *Site 17.* Minor to moderate erosion on outside of stream bend

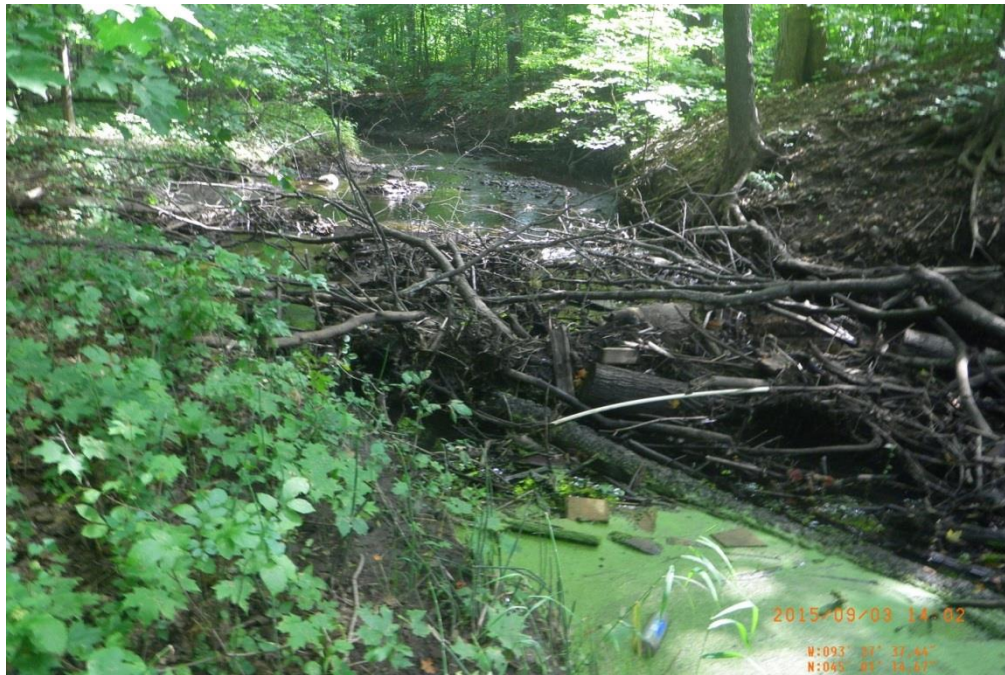
**Photo 17.** *Site 18.* Large woody debris in stream

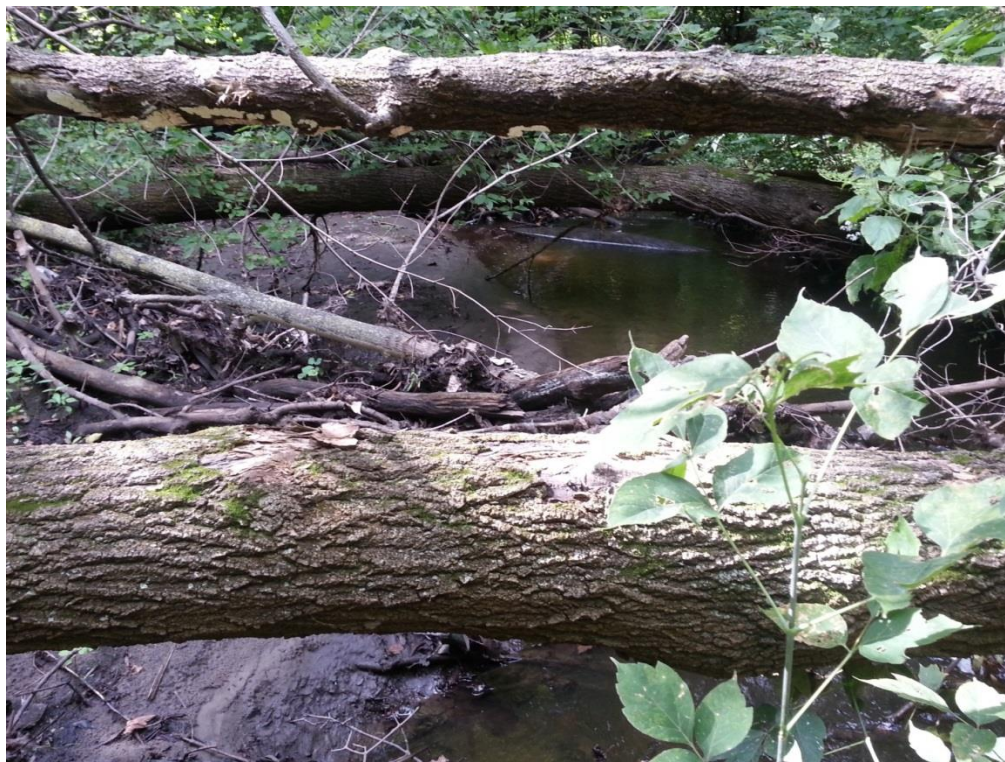
**Photo 18.** *Site 19.* Large woody debris in stream

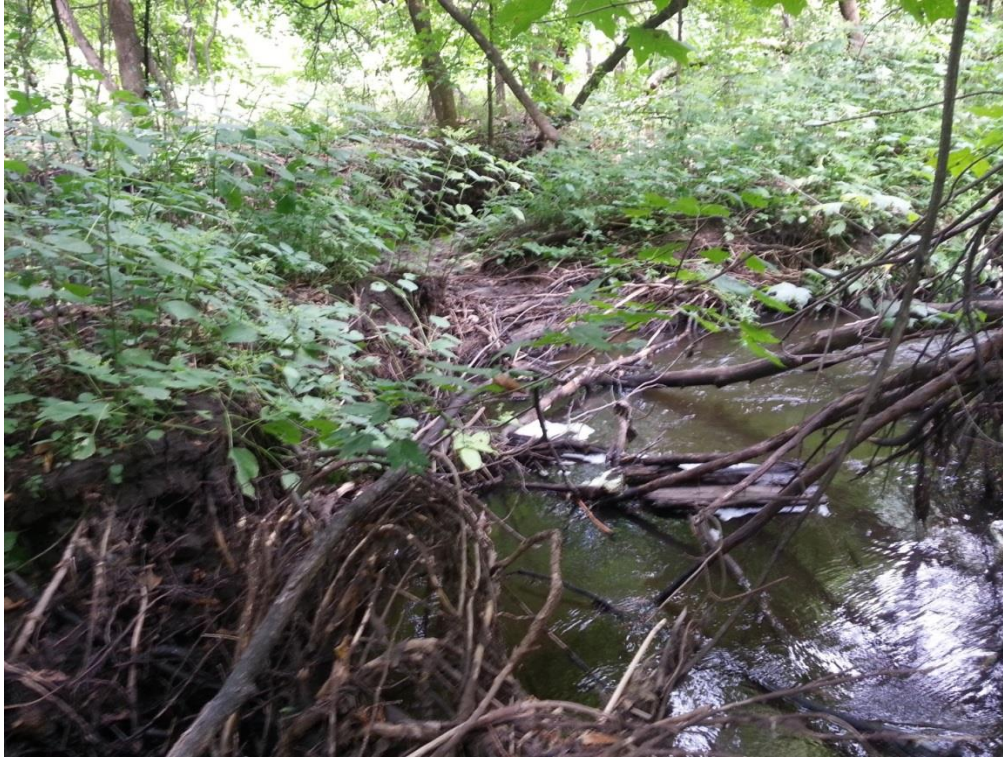
**Photo 19.** *Site 20.* Meander in process of being cut off

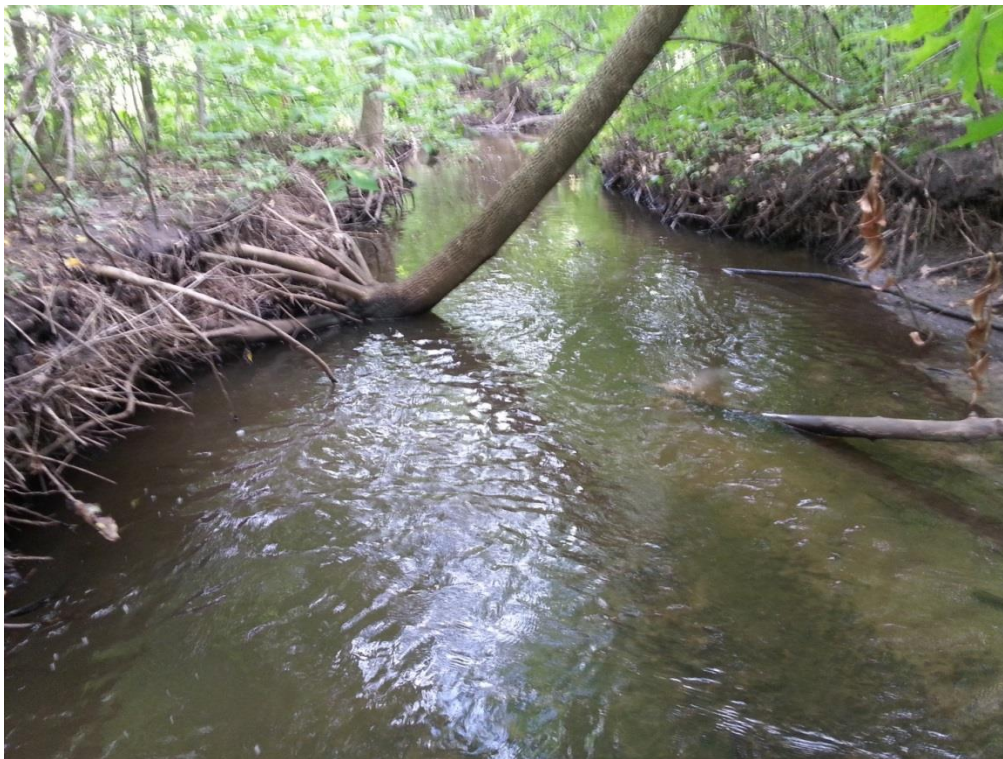
**Photo 20.** *Site 21.* Over-widened stream reach
