City Addendum No. 1 – February 26th, 2021

Re: Plymouth Ice Center – Roof Replacement Project
Plymouth Ice (PIC)
3650 Plymouth Blvd.
Plymouth, MN 55446

ARCHITECTURAL ADDENDUM NO. 1 - FEBRUARY 25, 2021

Technical Memorandum

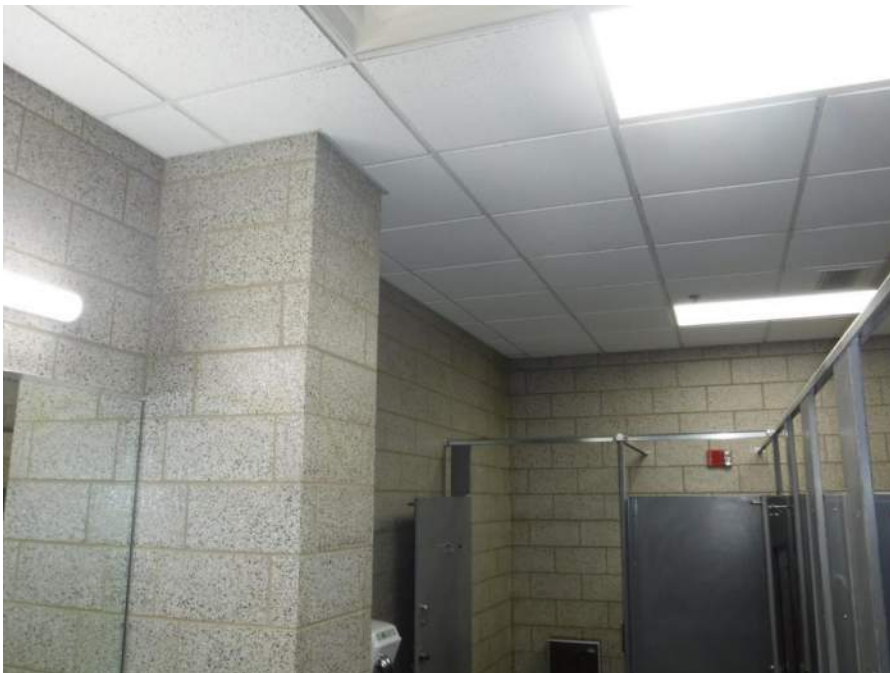
Location of reported leak in women's restroom

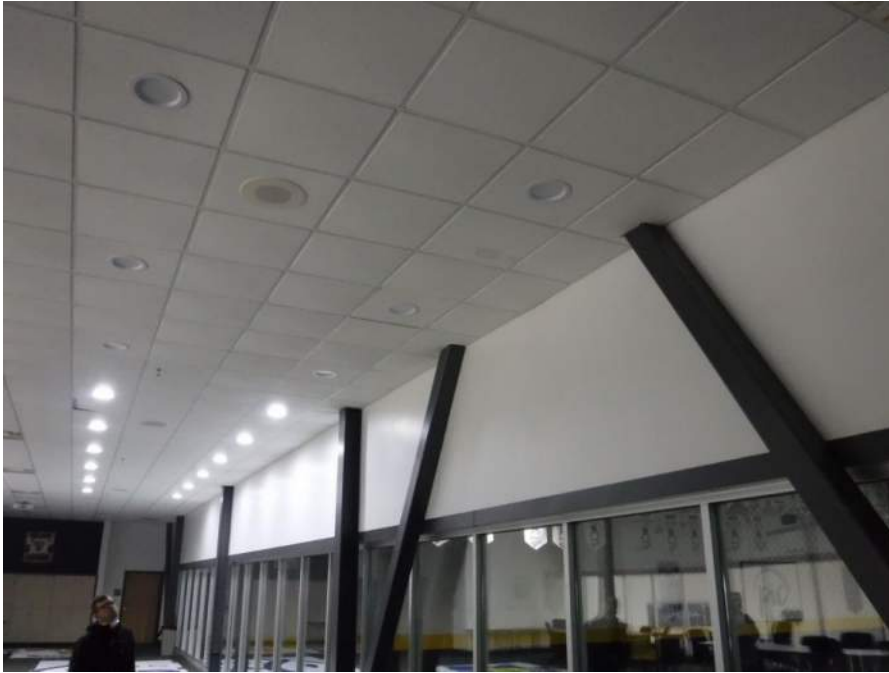
Stained ceiling tiles along wall between conference room and Rink A

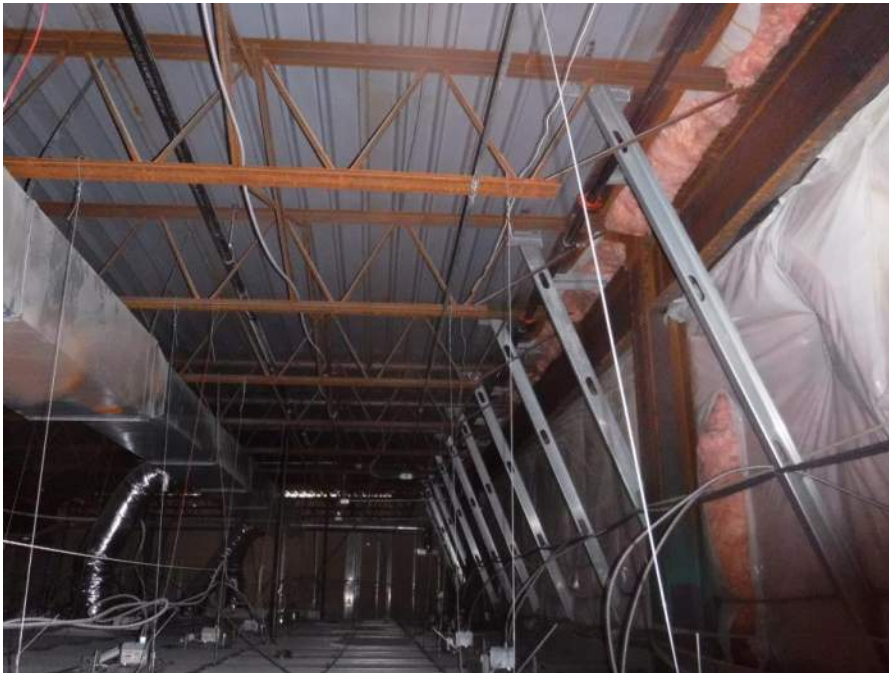
Ceiling plenum above stained ceiling tiles in previous photo

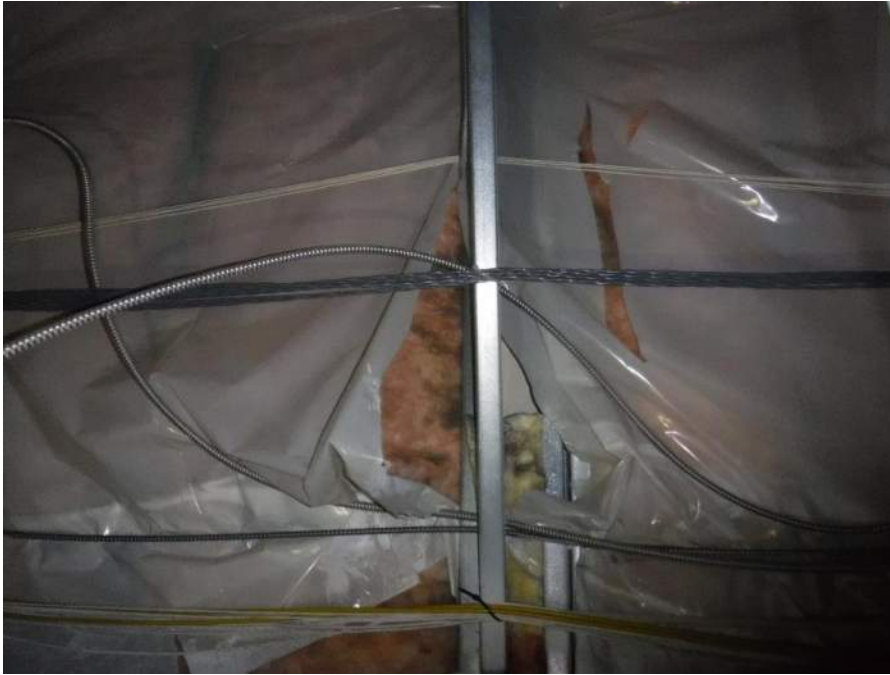
Ineffective vapor retarder on wall between conference room and Rink A, note discoloration on batt insulation

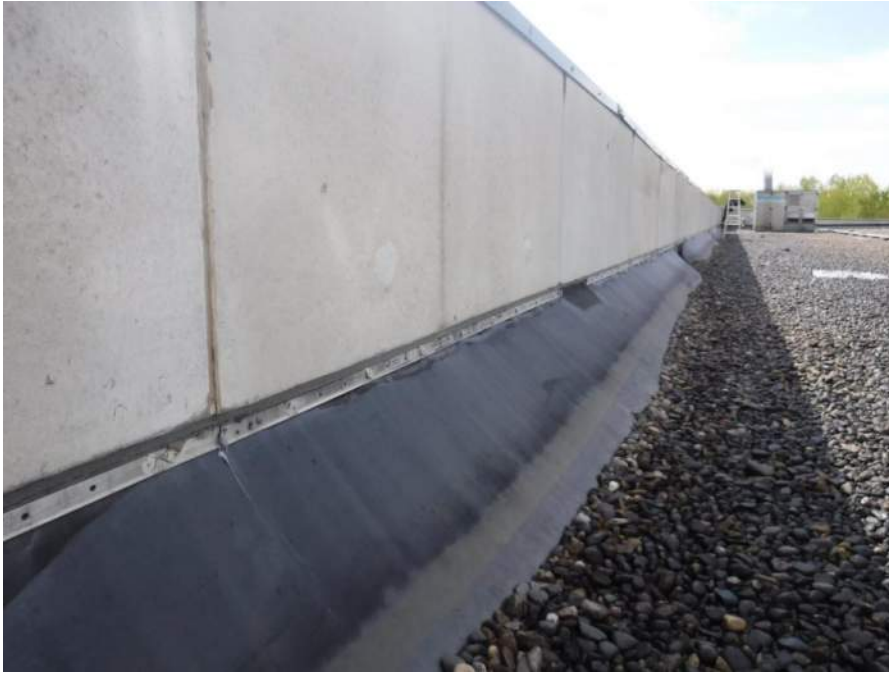
- A. EPDM membranes naturally shrink over time and ballasted roofs provide no resistance to the shrinking because the membrane is loose laid. This has resulted in the observed “tenting” at the perimeter of the ballasted roofs. Due to the observed tenting and age of the ballasted EPDM roofs, Pie recommends they are removed and replaced with a new fully adhered EPDM roof system. A fully adhered system offers advantages to a ballasted system because it is not prone to the shrinking issue discussed and leaks are able to be localized and repaired more effectively.

Typical “tenting” observed along ballasted roof perimeters

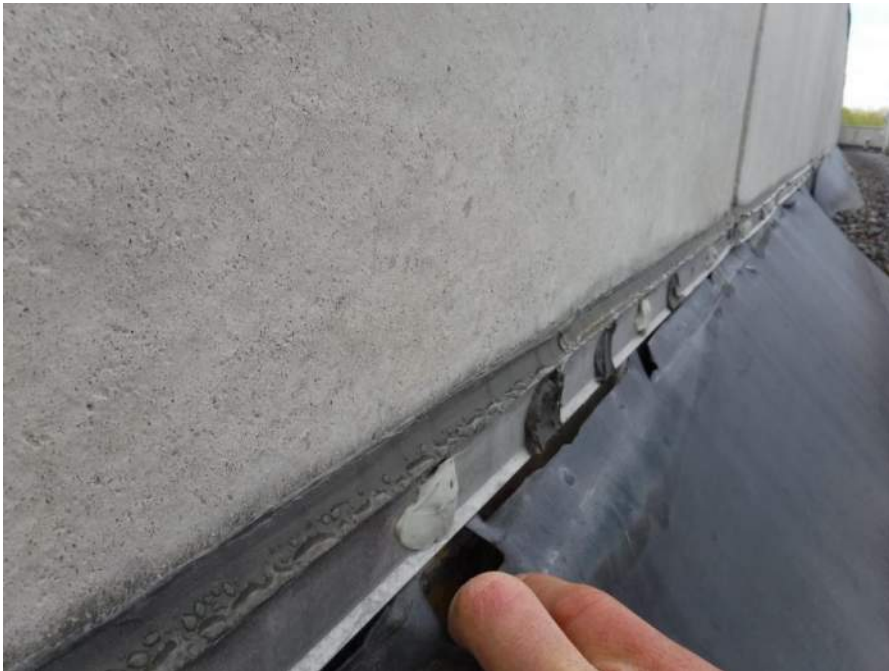
Typical holes in membrane below termination bar caused by “tenting”

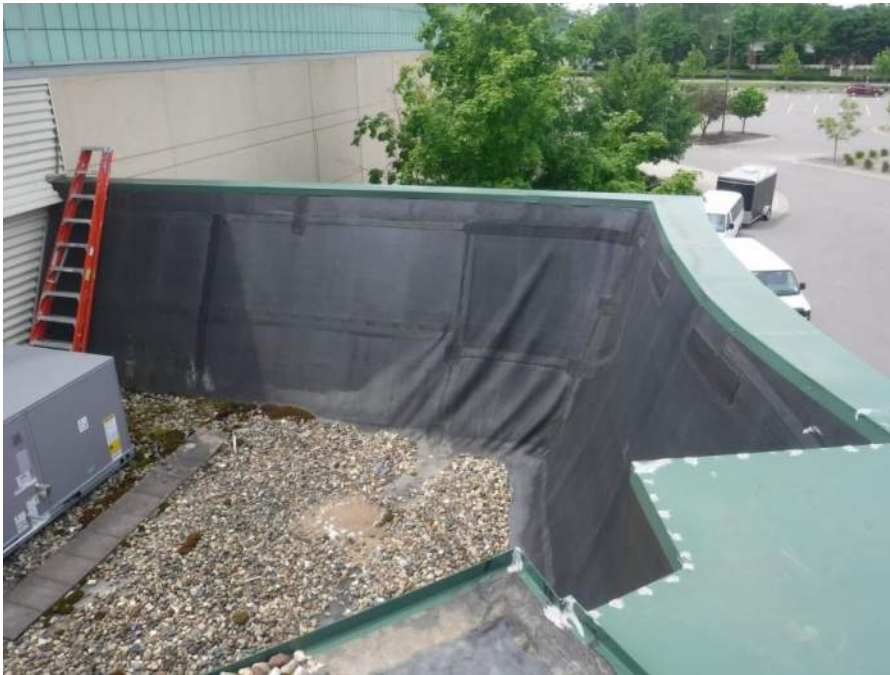
Unadhered membrane at back of sloped parapet west of entrance

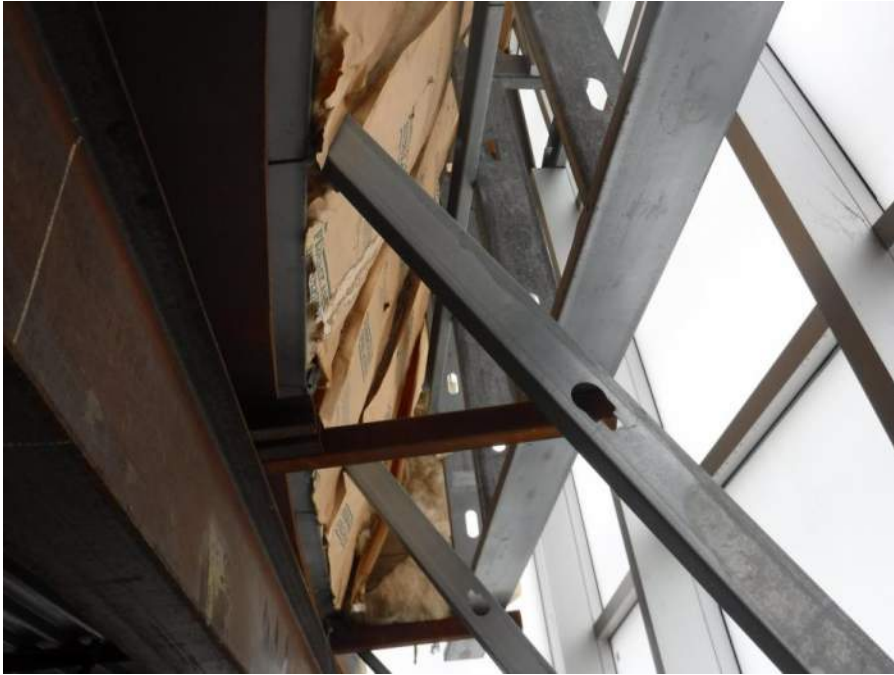
- D. At the sloped backside of the glazing system west of the entrance, the kraft-faced batt insulation does not provide an air-seal to prevent interior air from reaching the underside of the plywood and there is no vapor retarder to stop vapor drive. During winter months, warm interior air can come in-contact with the underside of the cold plywood causing potential for condensation. Interior-to-exterior vapor drive will also occur as the plenum space is warmed up by the solar heat gain from the translucent spandrel panels causing potential for moisture accumulation at the underside of the EPDM membrane. The membrane becoming unadhered has likely been caused by a combination of these two mechanisms. Due to this, Pie recommends that the new fully adhered roof assembly is continued up the sloped and vertical plywood to the coping. The new vapor retarder on the top side of the plywood will prevent vapor drive and the new exterior insulation will keep the underside of the plywood warm.

Existing conditions underneath sloped parapet, note staining on kraft-faced batt insulation

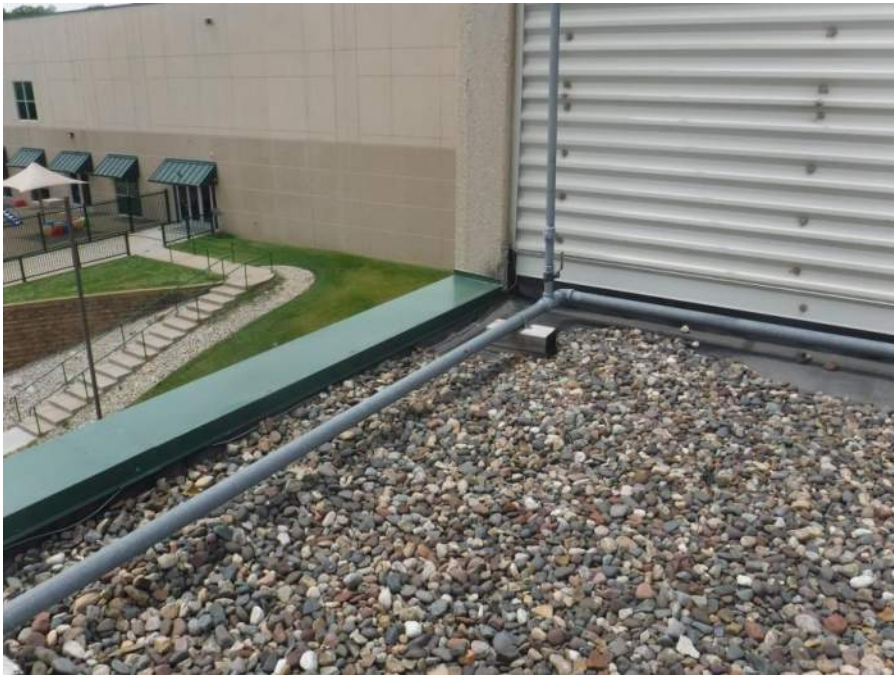
Typical coping with little to no slope

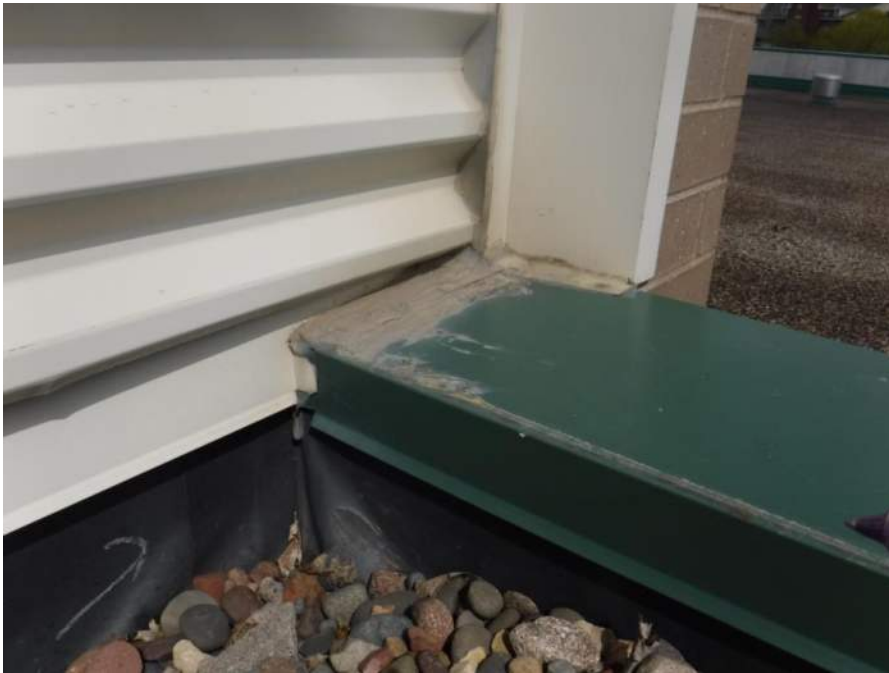
Coping termination to adjacent wall, note sealant applied in attempt to address leak

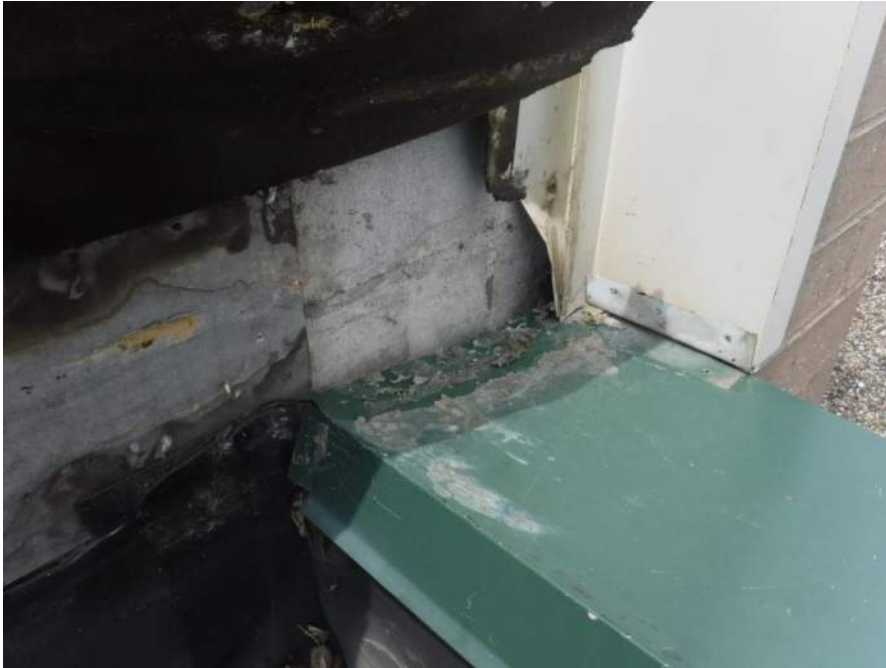
Test opening of previous photo, note membrane and metal does not extend onto adjacent wall at critical interface

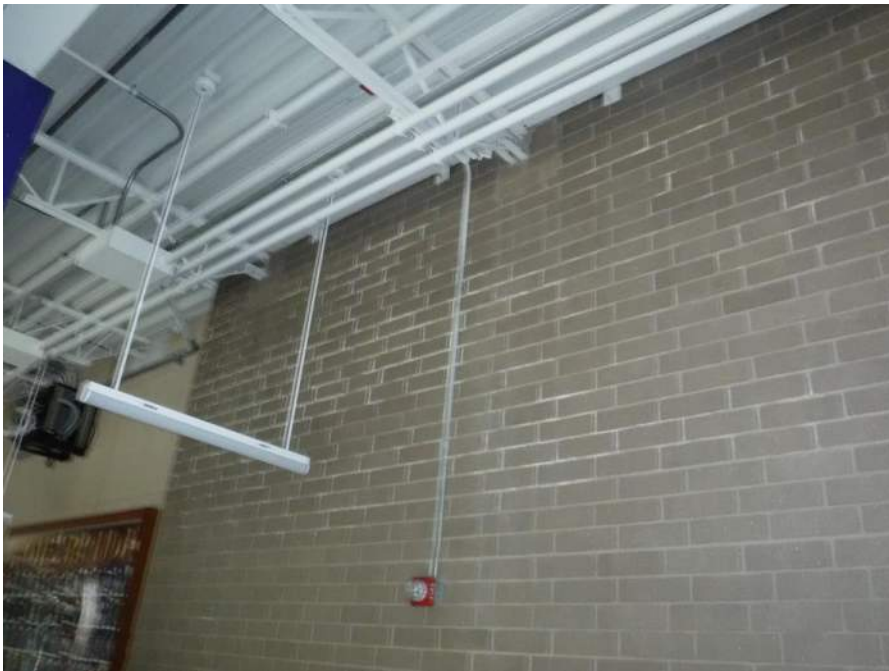
- A. There are several isolated areas where the roof membrane is upturned, sealed to the face of masonry veneer, and protected with reglet counterflashing. At these areas, no thru-wall flashings were observed. Efflorescence was observed on the north-facing masonry veneer below the Rink C roof.

Efflorescence observed on masonry veneer directly below previous photo is evidence of moisture within wall

- A. Masonry veneer is a porous material and when used as a cladding is intended to take on water. The air cavity behind the masonry provides a drainage cavity for the cladding and a water-resistive barrier (WRB) on the back-up wall prevents moisture from entering the building enclosure. Thru-wall flashings integrated with the WRB collect moisture accumulated behind the veneer and direct it to the exterior. Where the roof is upturned and sealed to the face of masonry veneer with no thru-wall flashing above, water that accumulates in the masonry veneer cladding during wind-driven rain events is free to drain down past the roof to the building interior. Efflorescence observed on the north-facing masonry veneer below the Rink C roof is evidence of this occurring. Due to this, Pie recommends that new thru-wall flashings are installed at all locations where the roof is upturned and sealed to the masonry veneer.

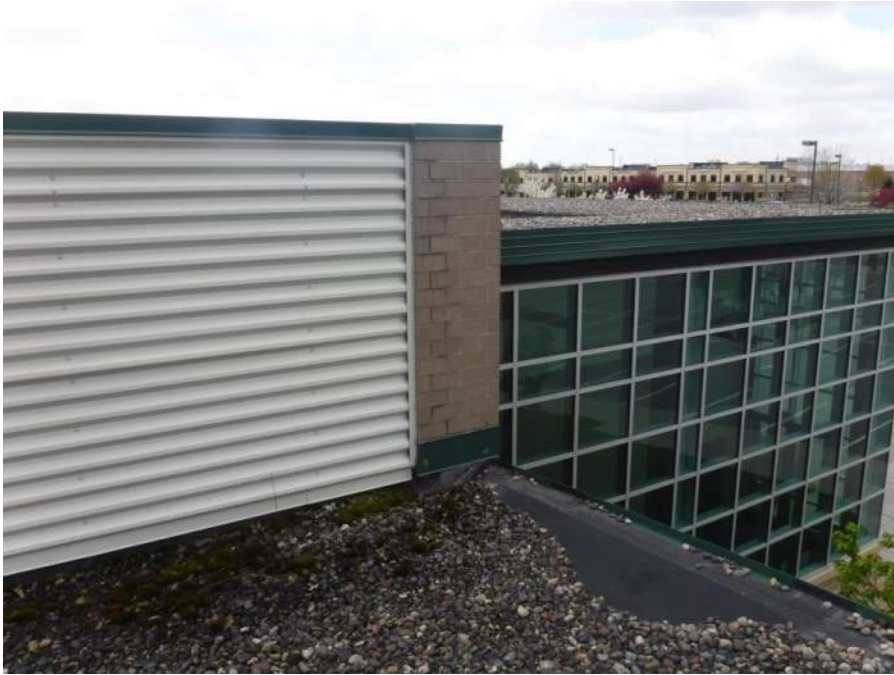
Roof terminated to face of masonry veneer wall return at Rink A southwest penthouse

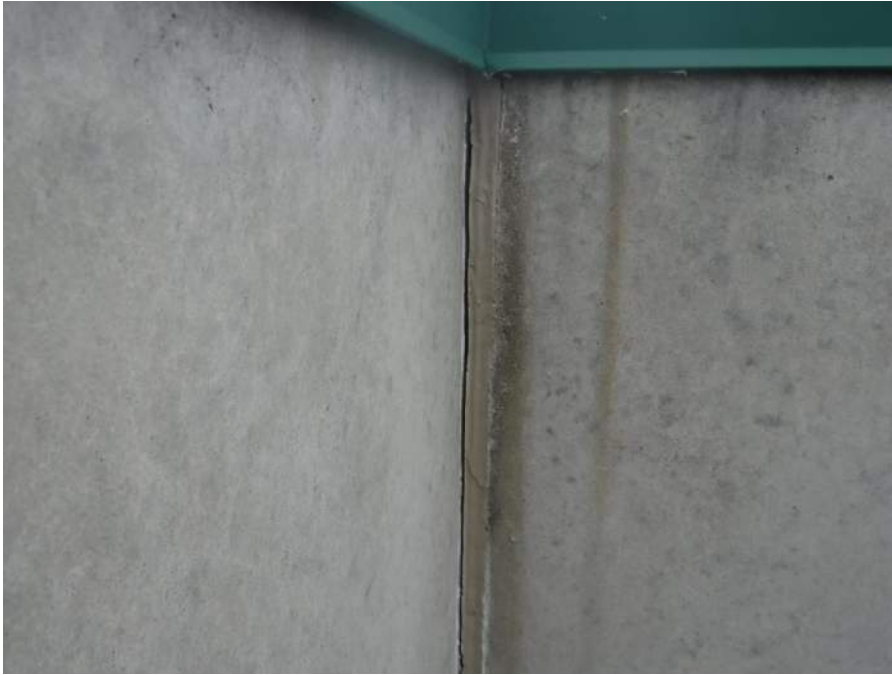
Typical failed vertical sealant joint between precast panels and discoloration

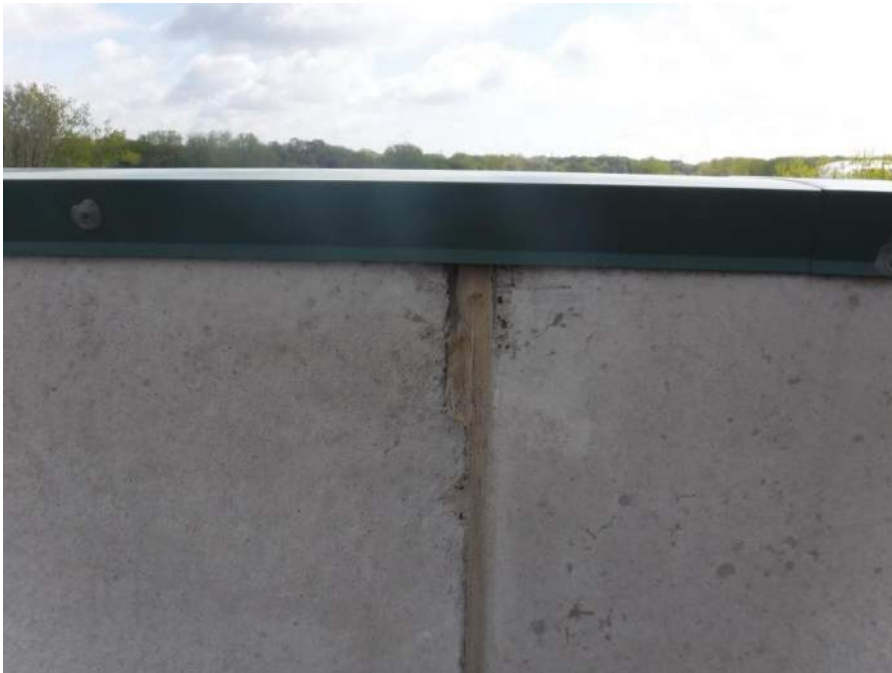
Typical failed vertical sealant joint between precast panels

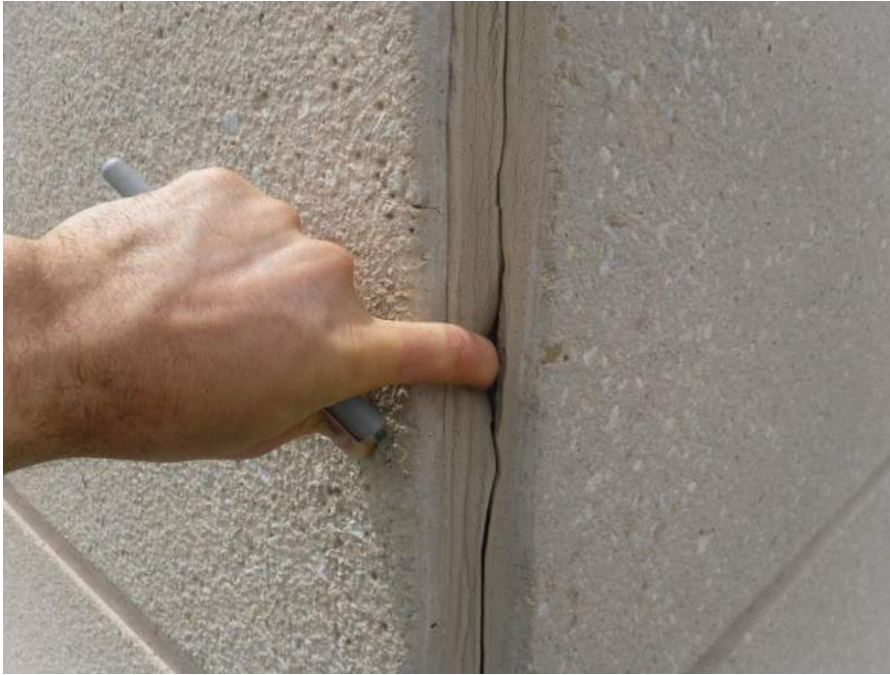
Failed sealant joint at precast outside corner

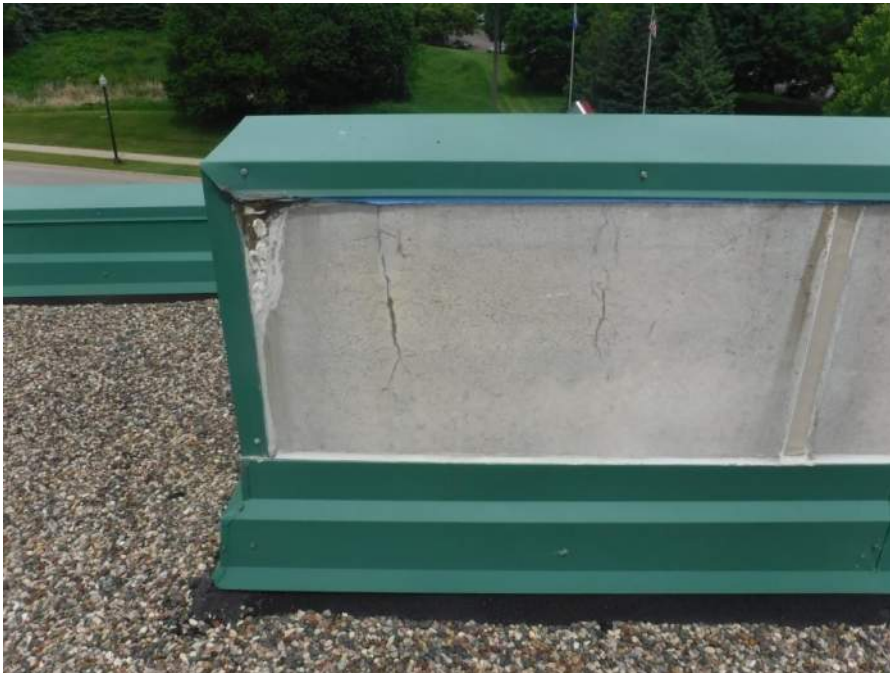
Excessive sealant applied to damaged precast corner and typical hairline cracks

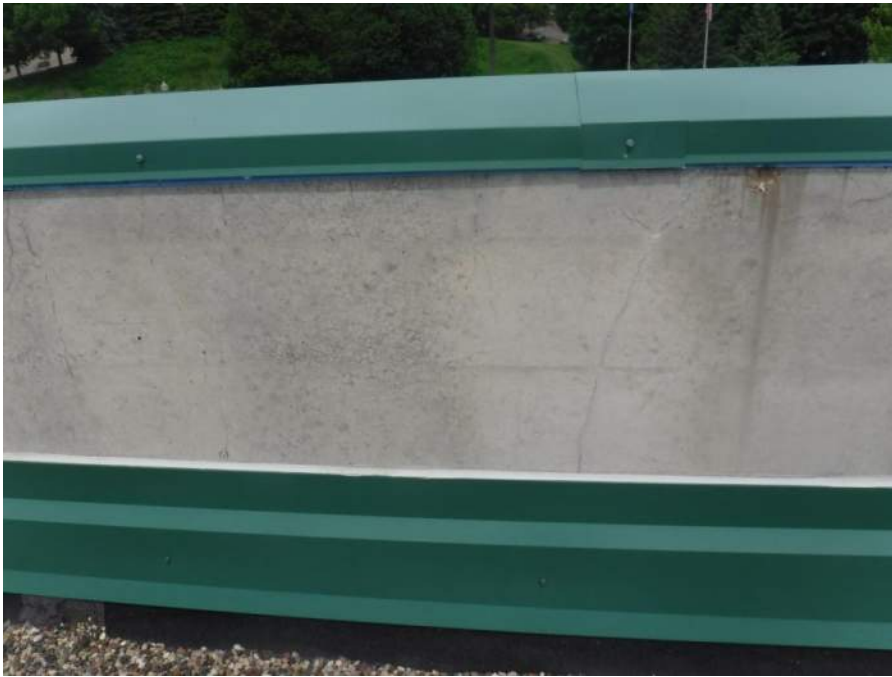
Typical hairline cracks in precast panel

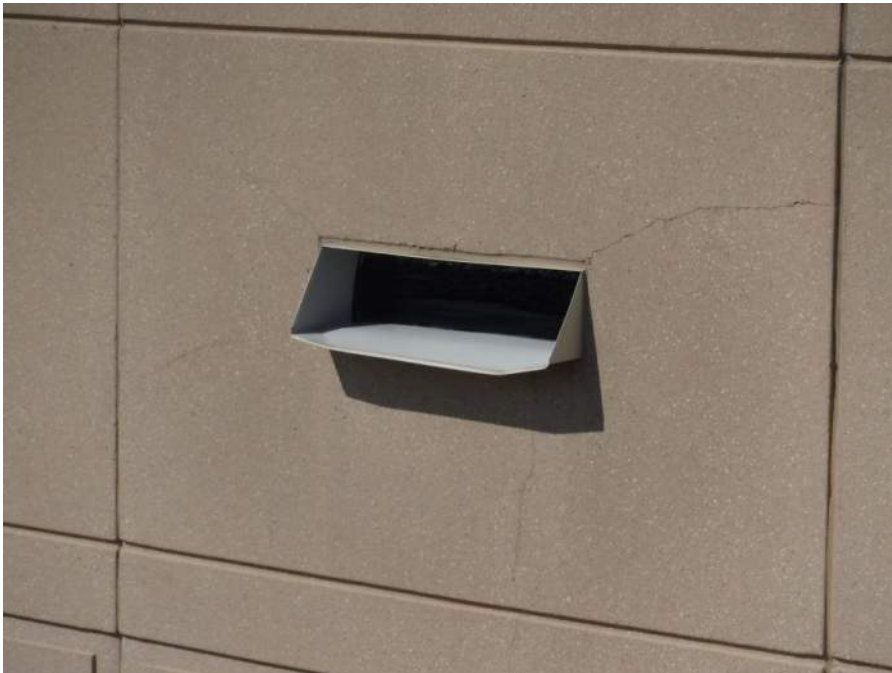
Diagonal cracks originating at corners of scupper penetration

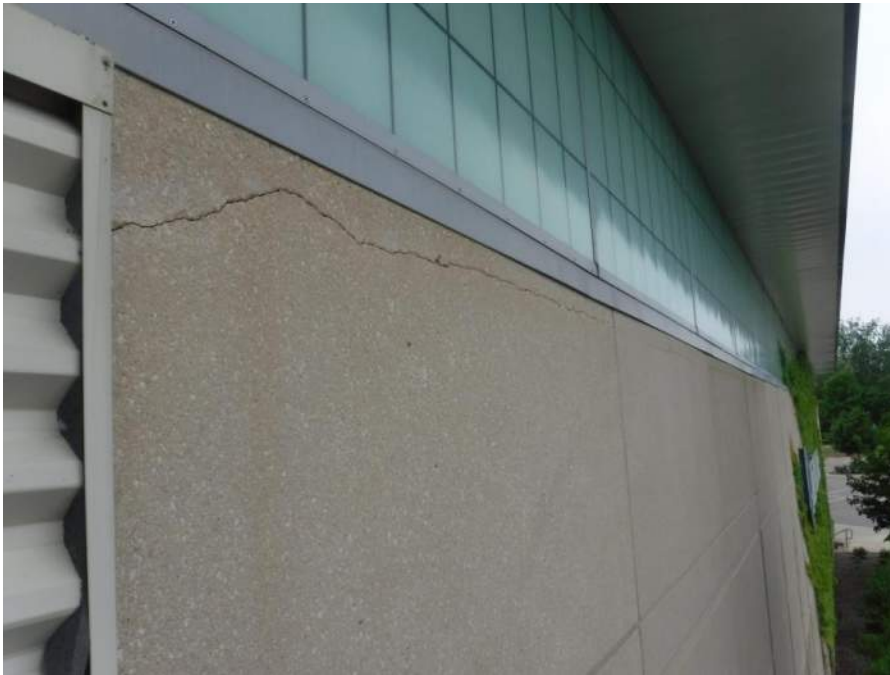
Horizontal crack underneath Rink A clearstory translucent panel

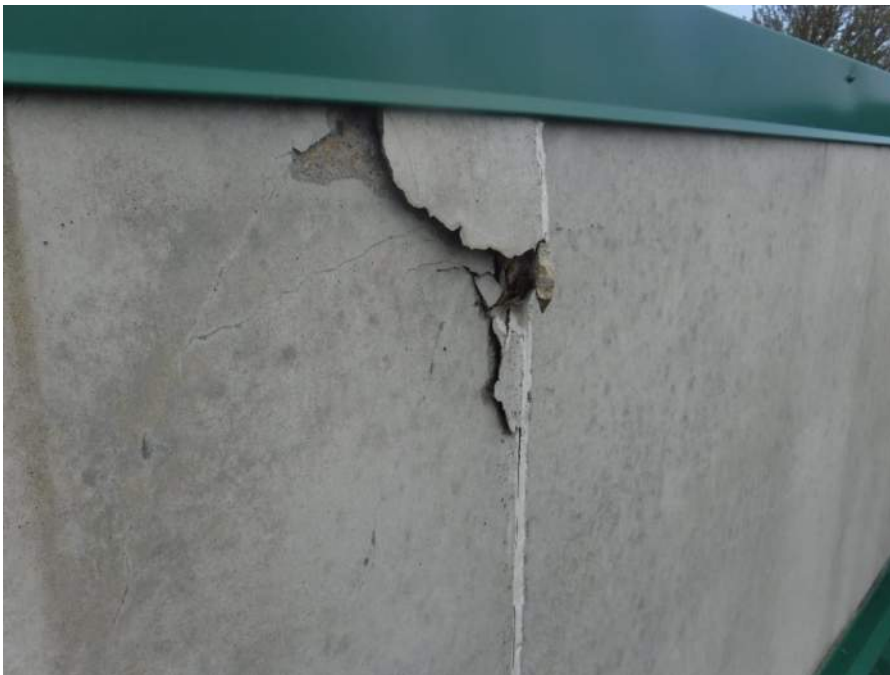
Observed spall in precast, typically caused by presence of moisture and freeze-thaw cycling

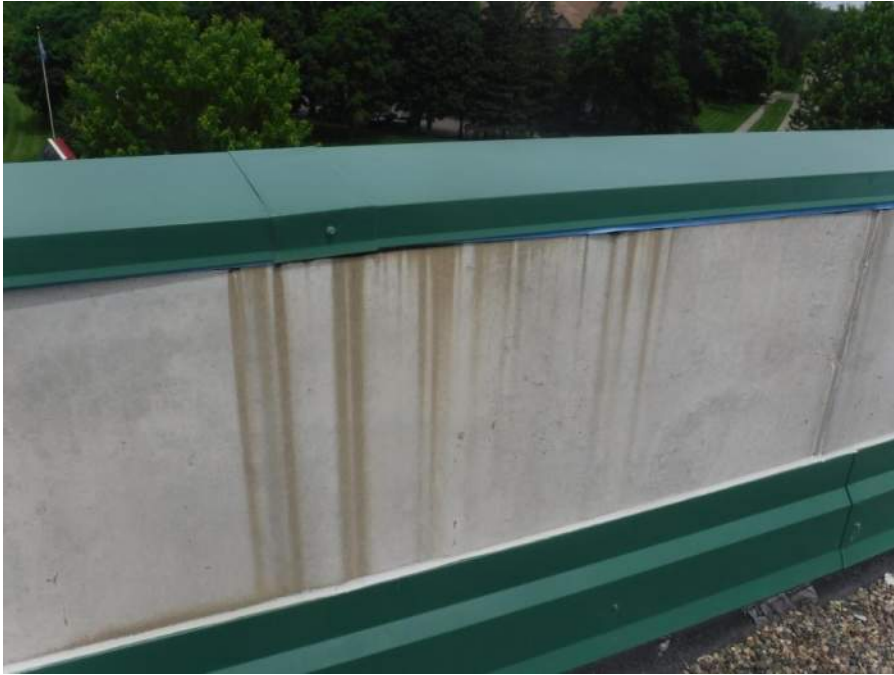
Typical staining originates from beneath coping

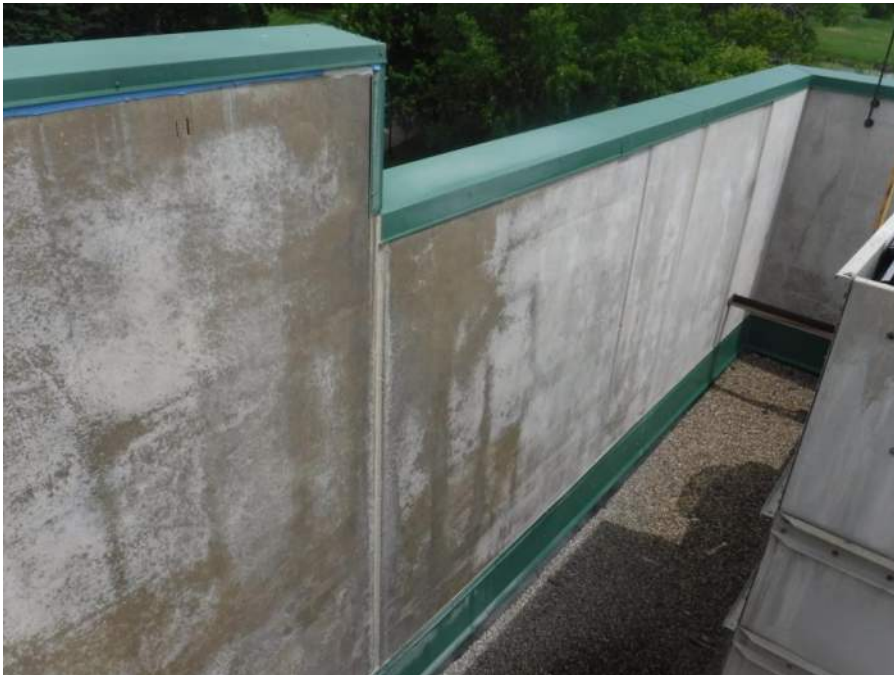
Precast discoloration observed adjacent to cooling tower

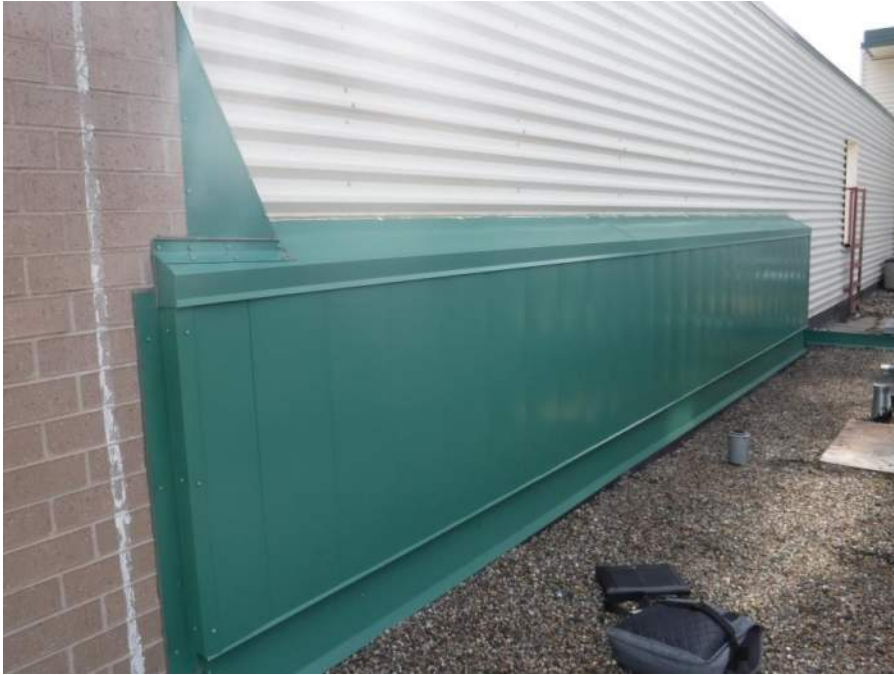
Partial height CMU wall clad with flat-seam metal panel

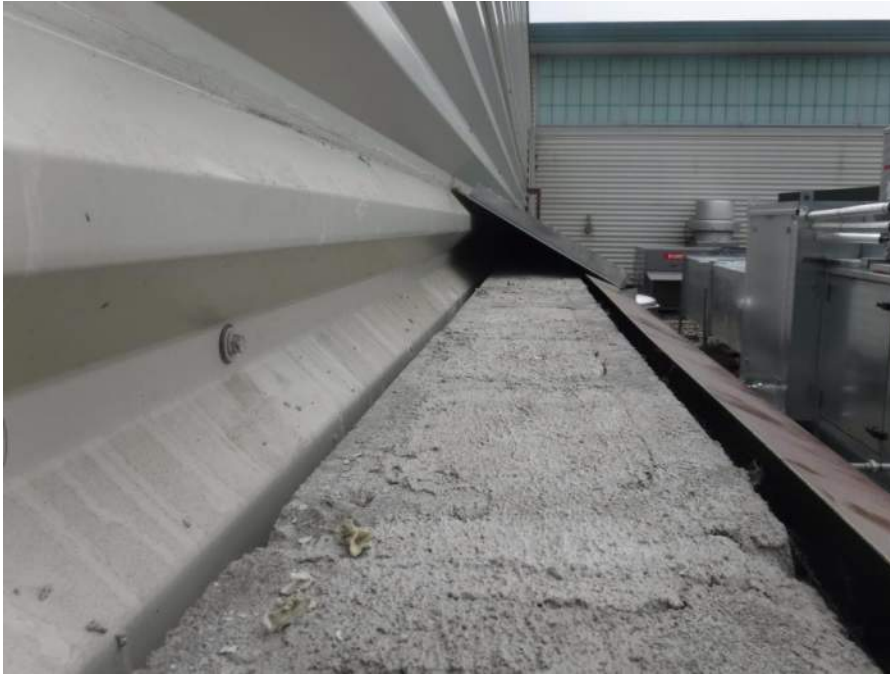
Space between corrugated metal panel and CMU wall is a potential path for water infiltration

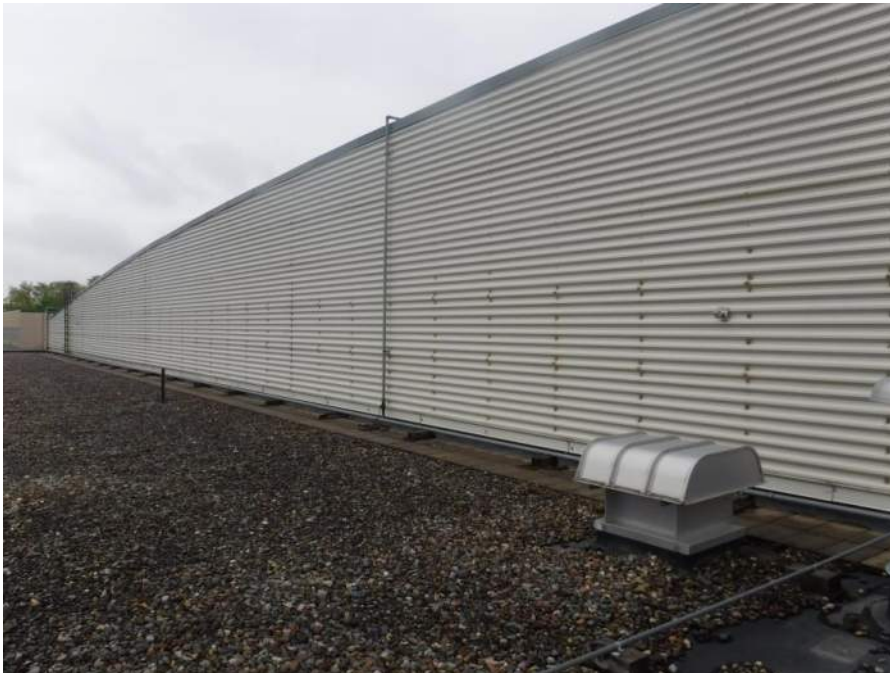
Corrugated metal panel on east wall of Rink A above Rink B

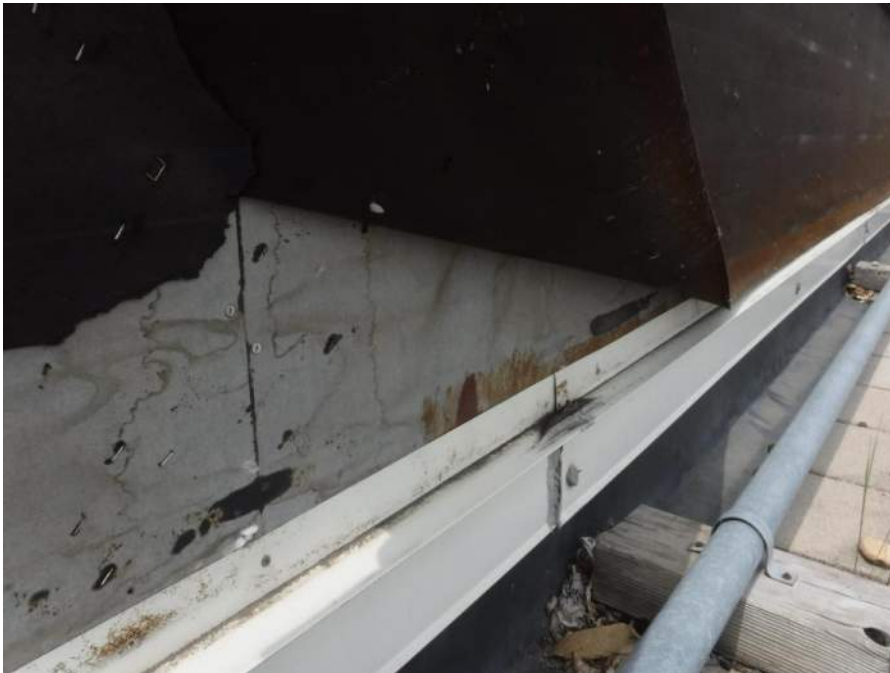
- D. The corrugated metal panel-clad walls consist of an interior poly vapor retarder, steel stud framing with batt insulation, exterior gypsum sheathing, and felt paper behind the corrugated metal panel. Where a lower roof meets this type of wall, the membrane is upturned behind the metal panel and felt paper in a shingle-lap configuration. Staining was observed on the gypsum sheathing indicating the presence of moisture behind the felt paper.

Roof membrane upturn is concealed behind metal flashing which felt paper shingle-laps onto, staining on gypsum sheathing indicates presence of moisture behind felt paper WRB

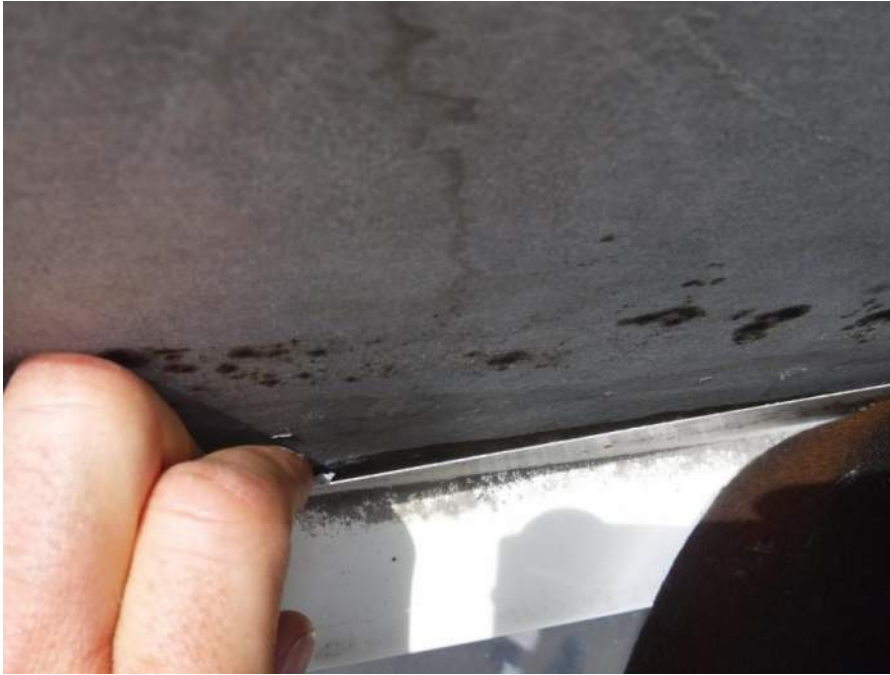
Upturned membrane behind metal flashing in previous photo

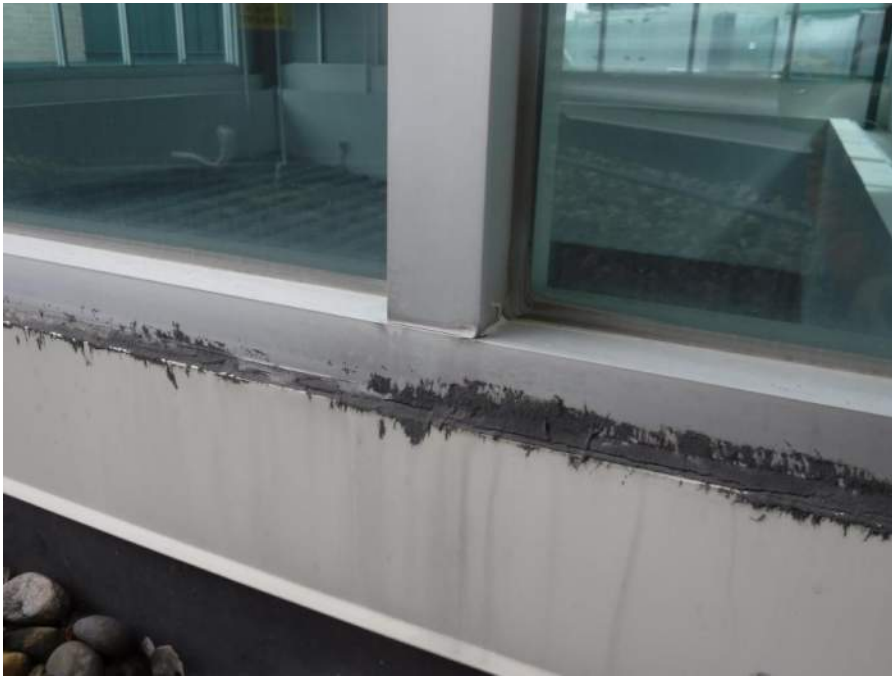
- A. The clearstory window units above the entrance have been wet-sealed, with sealant applied to the aluminum framing joints, glass to aluminum joints, and perimeter joints. Some areas of sealant appear to have multiple applications and most of the sealant has failed.
- B. The glazing system west of the entrance has a sealant joint at the sill that is discontinuous at the bottom of vertical members and staining was observed on the curb below at these locations. Staining was also observed on the curb on the interior side of the glazing system. The system is continuous past the suspended ceiling up to the roof coping. The spandrel panels above the suspended ceiling are translucent, allowing daylight into the plenum space between the suspended ceiling and the roof.

Close-up of window sill, note sealant at horizontal-to-vertical joint, majority of sealant has failed

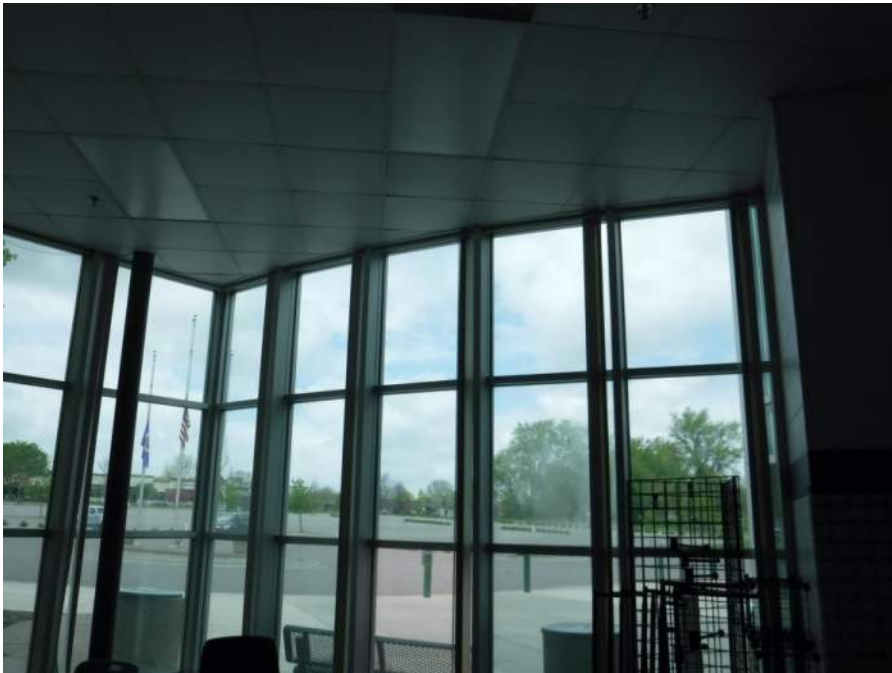
Full-height glazing system in room west of entrance

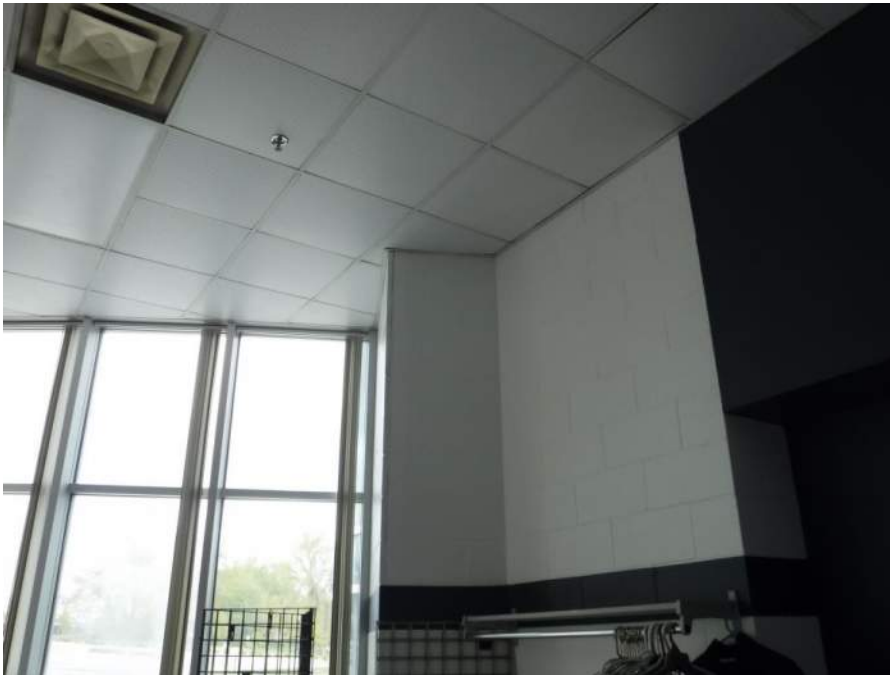
Staining below ceiling observed on CMU wall adjacent to glazing

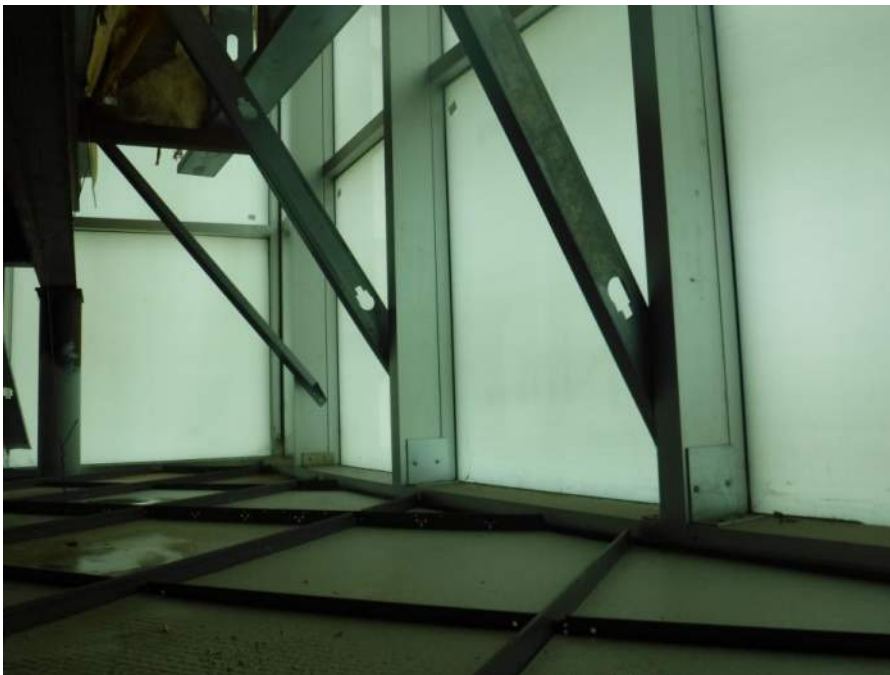
Existing conditions above ceiling, note standing water on ceiling tiles

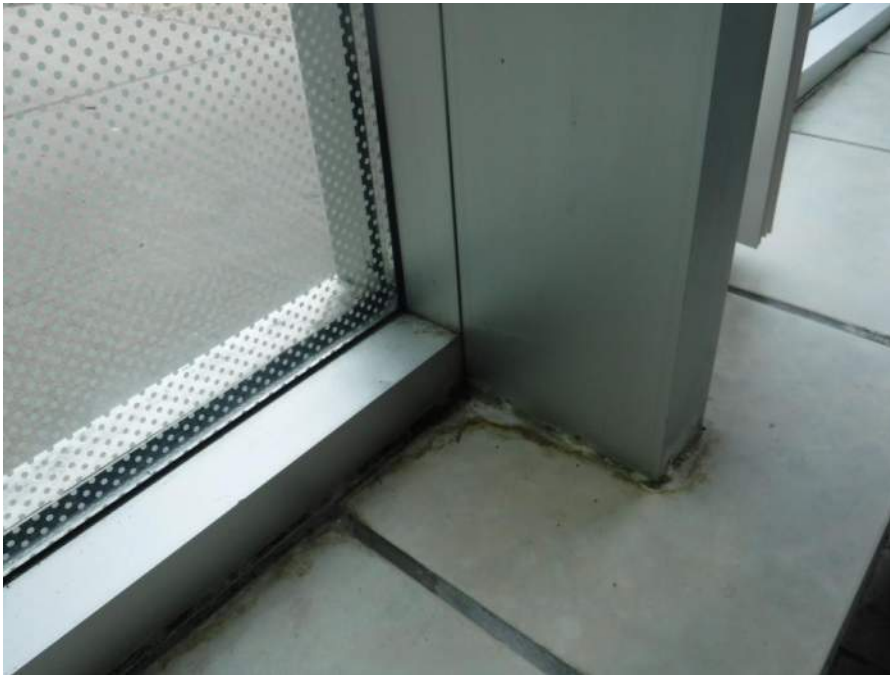
Staining at base of glazing system, note vertical aluminum tube providing reinforcement of store front verticals

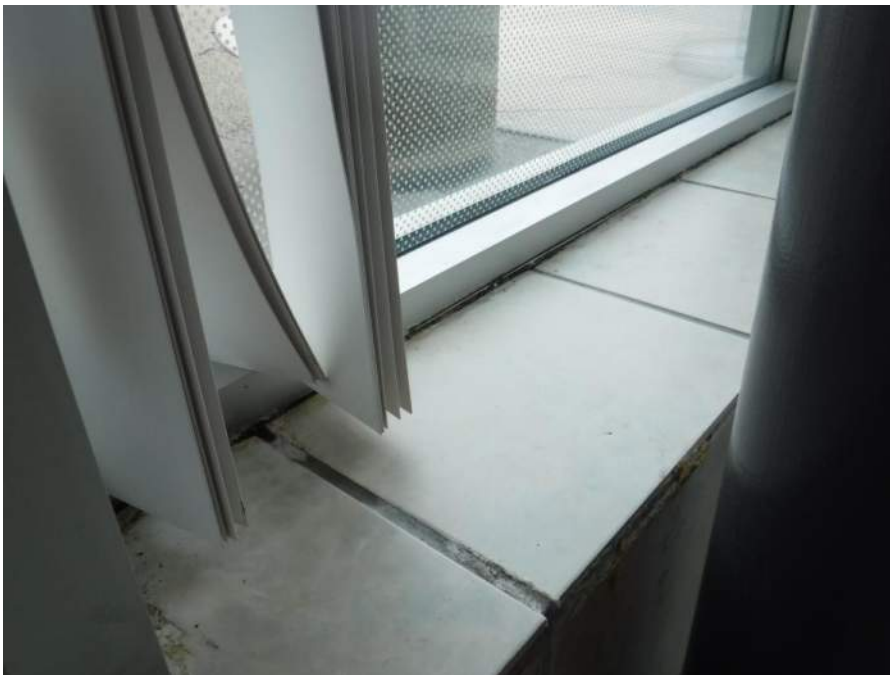
Staining at base of glazing system

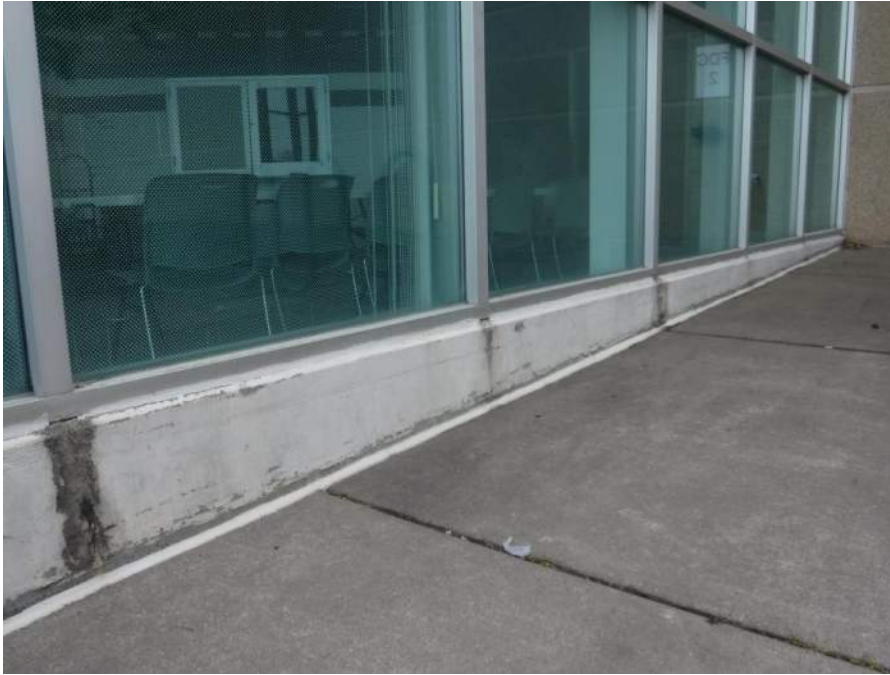
Exterior sill condition, note sealant joint between sill and curb is discontinuous at verticals and staining below verticals
