Dundee Nursery Redevelopment

Environmental Assessment Worksheet

March 2021

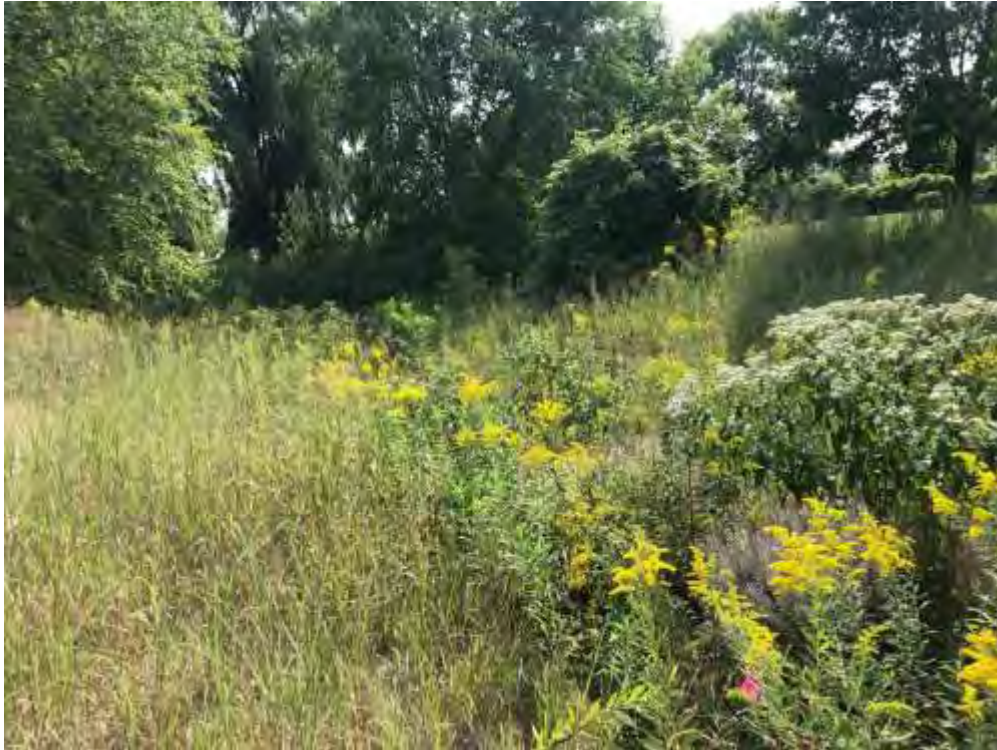
Photo 3: Wetland 2 looking south from parking lot outlet

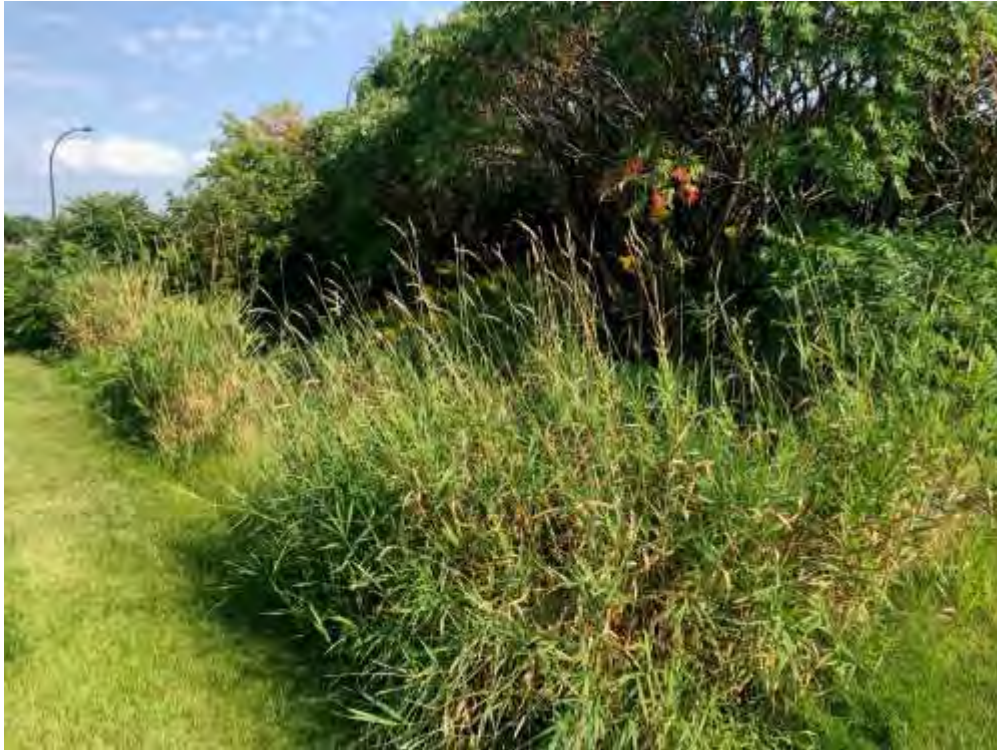
Photo 5: Short swale connecting Wetland 3 and Wetland 2

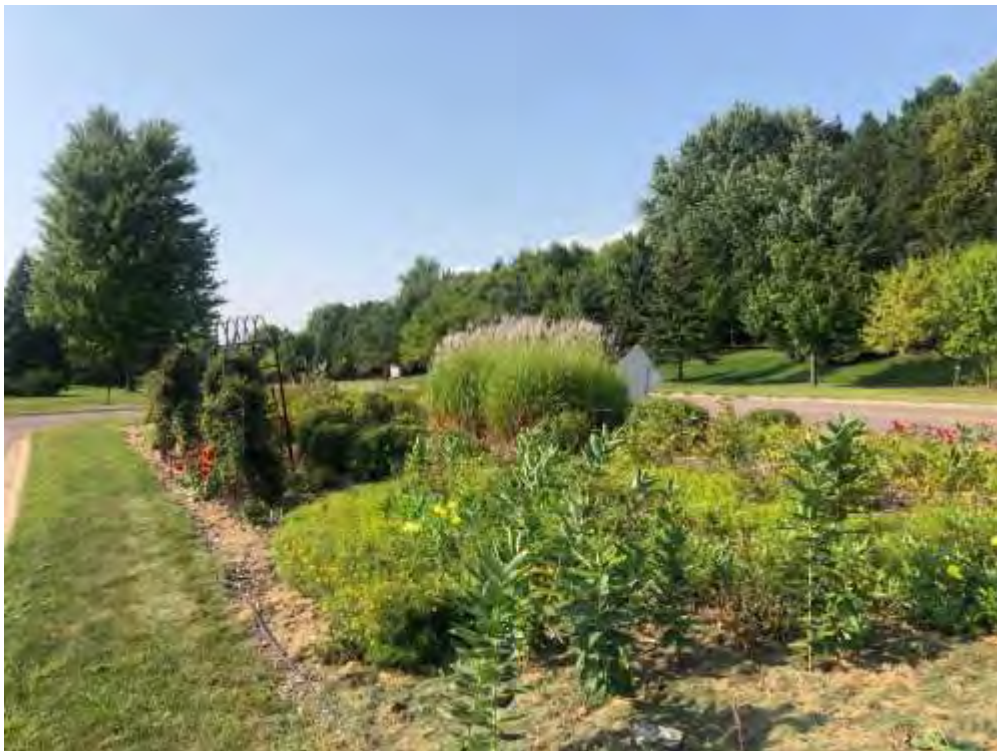
Photo 6: Rain garden on east side of parking lot looking north

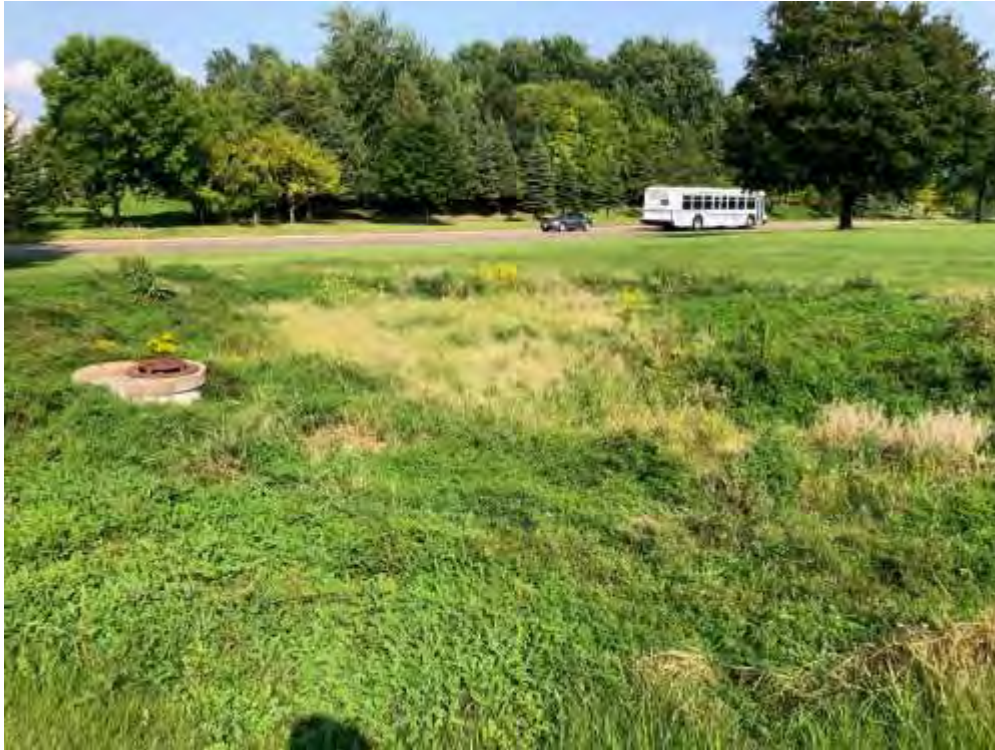
Photo 7: Infiltration area north of church looking east
