City Addendum No. 1 – February 26th, 2021

Re: Plymouth Ice Center – Roof Replacement Project
Plymouth Ice (PIC)
3650 Plymouth Blvd.
Plymouth, MN 55446

ARCHITECTURAL ADDENDUM NO. 1 - FEBRUARY 25, 2021

Technical Memorandum

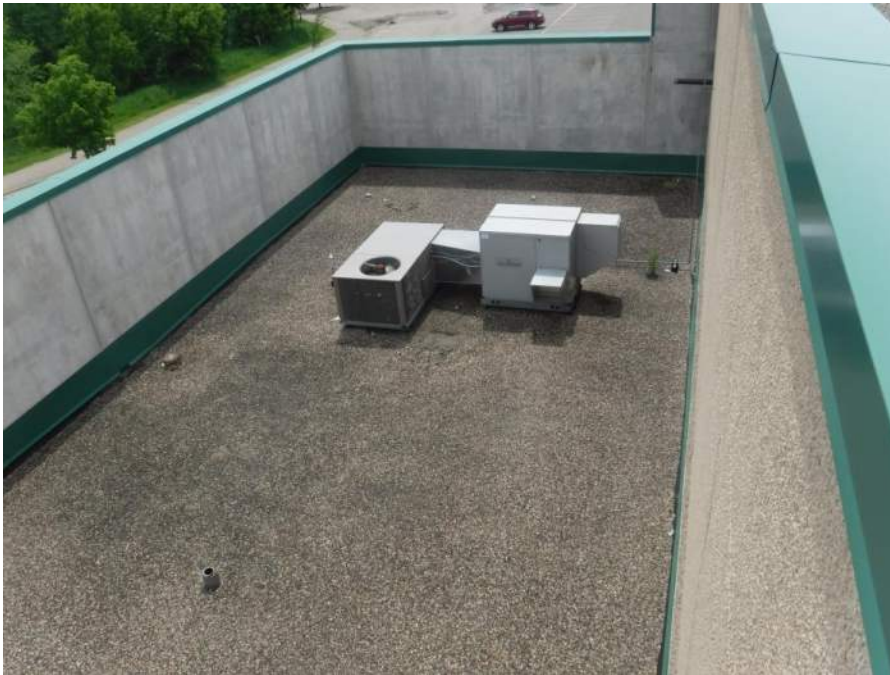
- B. The polyiso insulation in the sample cores was found to be dry, except for the sample core on the lowest roof east of Rink C which was saturated.
- C. Ponding water was present along the roof drains of Rink A. The primary roof drains appeared to be at a higher elevation than the low point of the roof. No tapered insulation was present between the primary roof drains, referred to as “crickets”, to divert water to the drains.

South lower roof east of Rink C, note sample core insulation was saturated

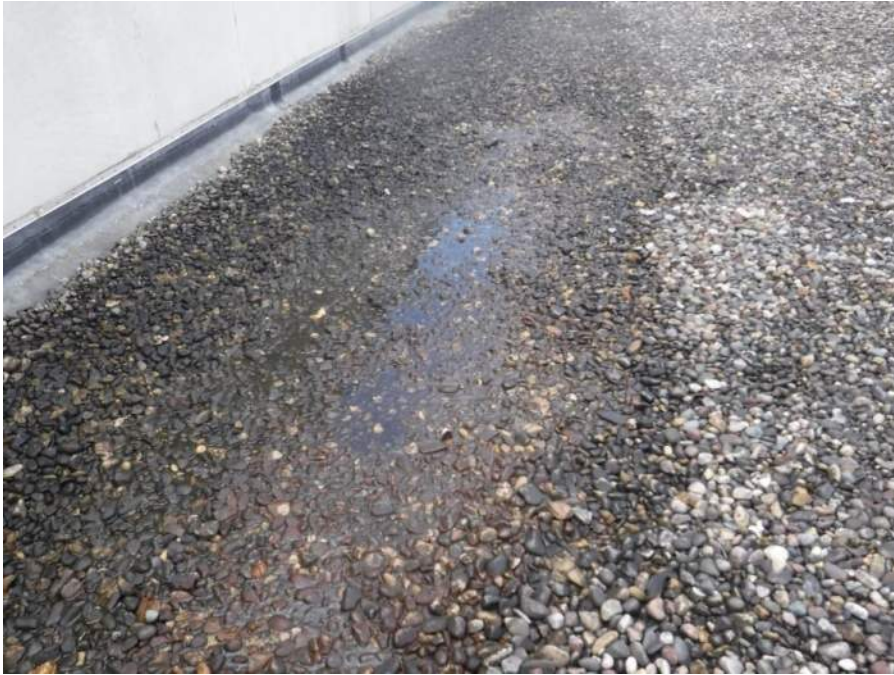
Standing water on Rink A roof

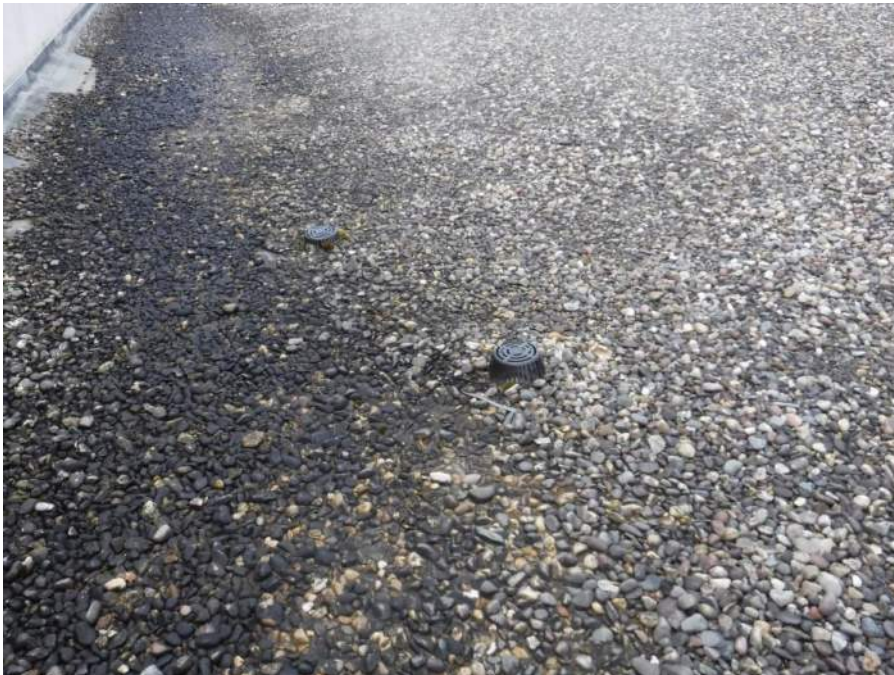
Rink A primary roof drain at higher elevation than standing water

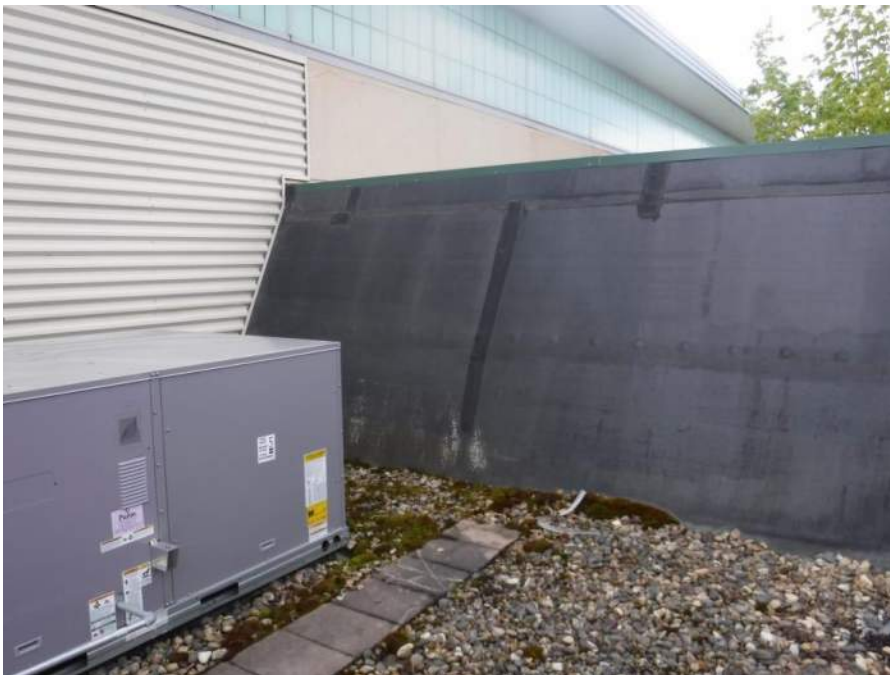
Sloped parapet west of entrance

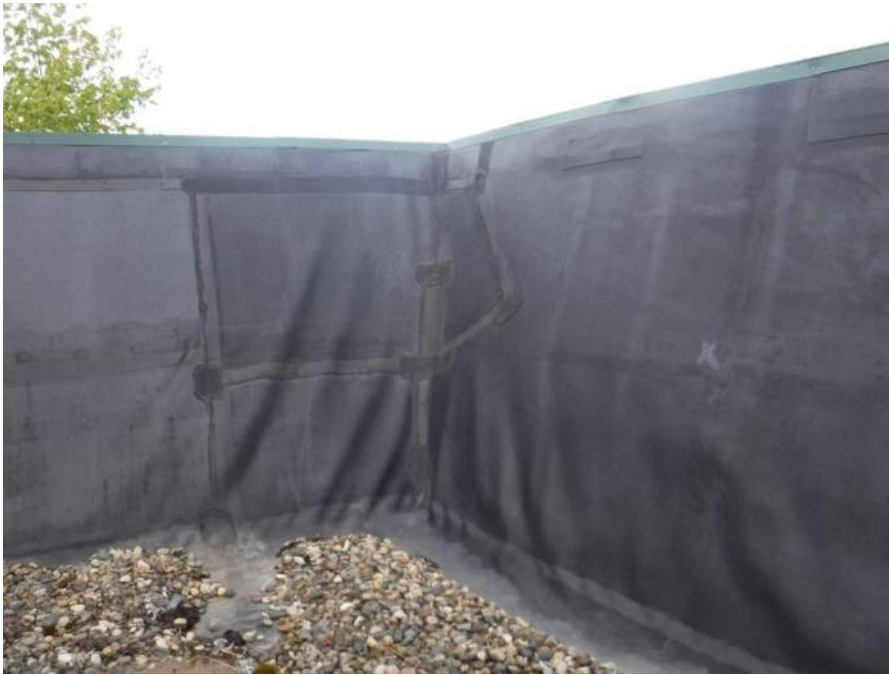
- F. At the glazing system west of the entrance, the backside of the parapet consists of sloped or vertical plywood with EPDM membrane that has become unadhered. From the interior, kraft-faced batt insulation was observed in the stud cavities of the sloped framing. No vapor retarder was present, and staining was observed on the insulation.
- G. Parapet and curb metal copings have little to no slope.
- H. Where parapets and curbs interface with adjacent walls, the cap membrane flashings have no end dam onto the adjacent wall and most of the metal coping end dams are reliant on sealant to maintain water tightness.

Unadhered membrane at back of sloped parapet west of entrance

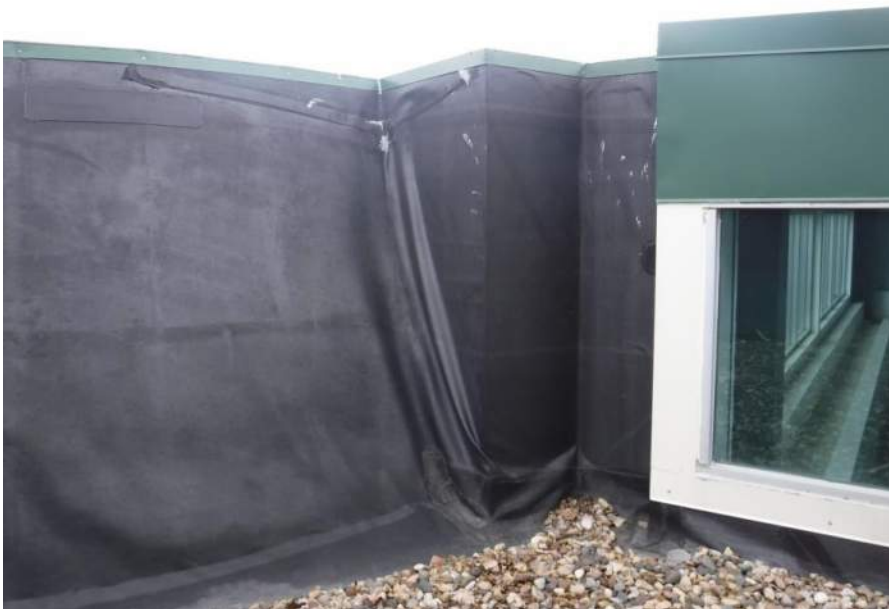
Unadhered membrane at back of sloped and vertical parapet west of entrance

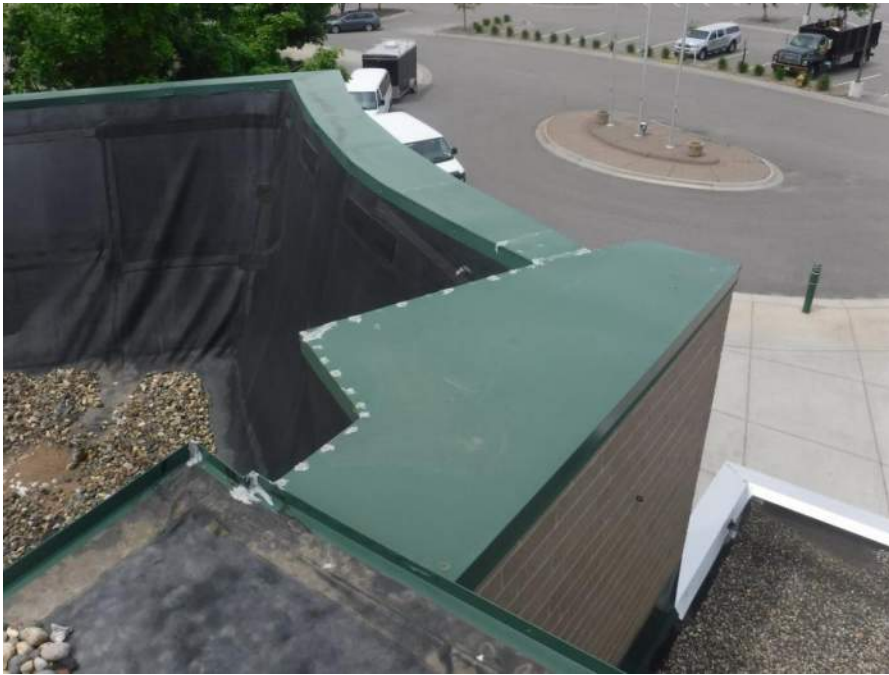
Wide coping west of entrance with little to no slope

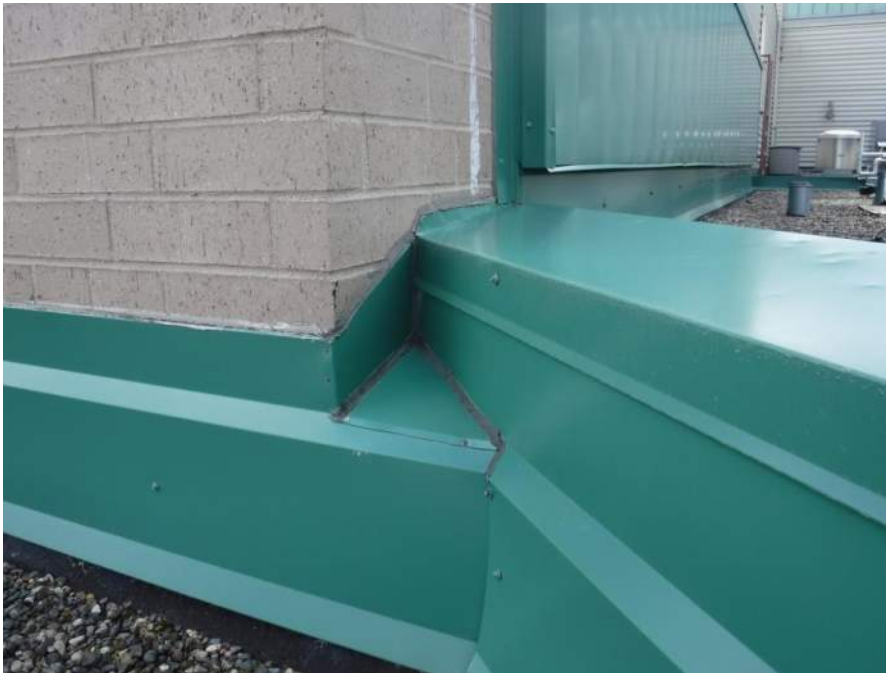
Coping termination to adjacent masonry wall with little upturn and no thru-wall flashing above

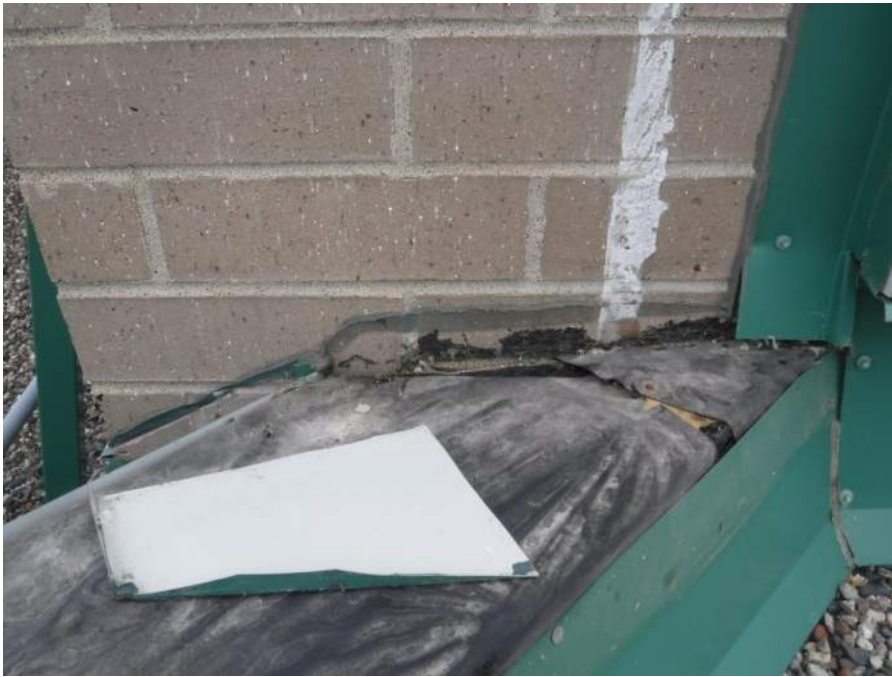
Test opening of previous photo, note lack of upturn and void in membrane flashing

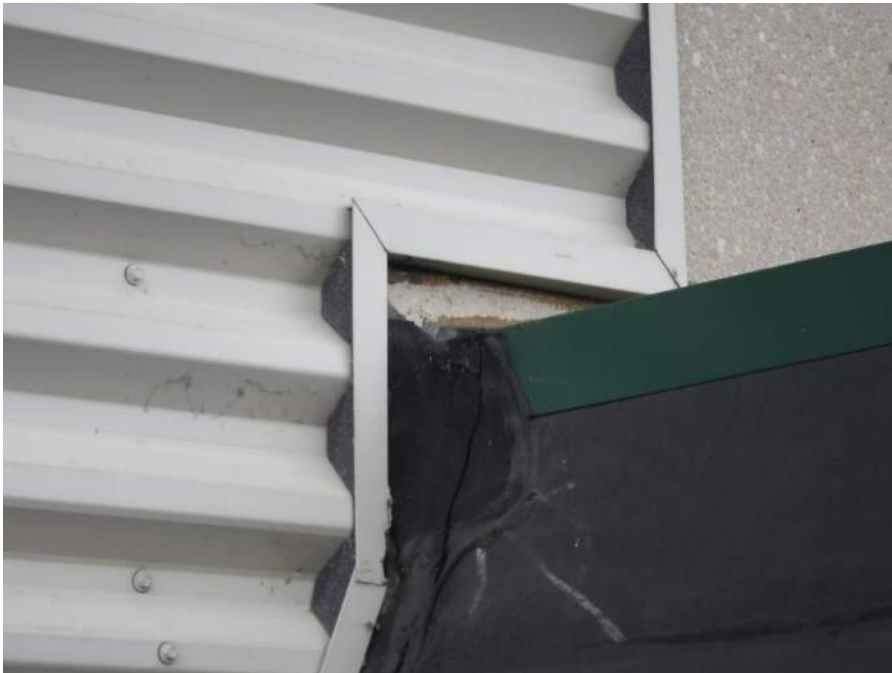
Coping termination to adjacent precast wall with no upturn of membrane or metal coping

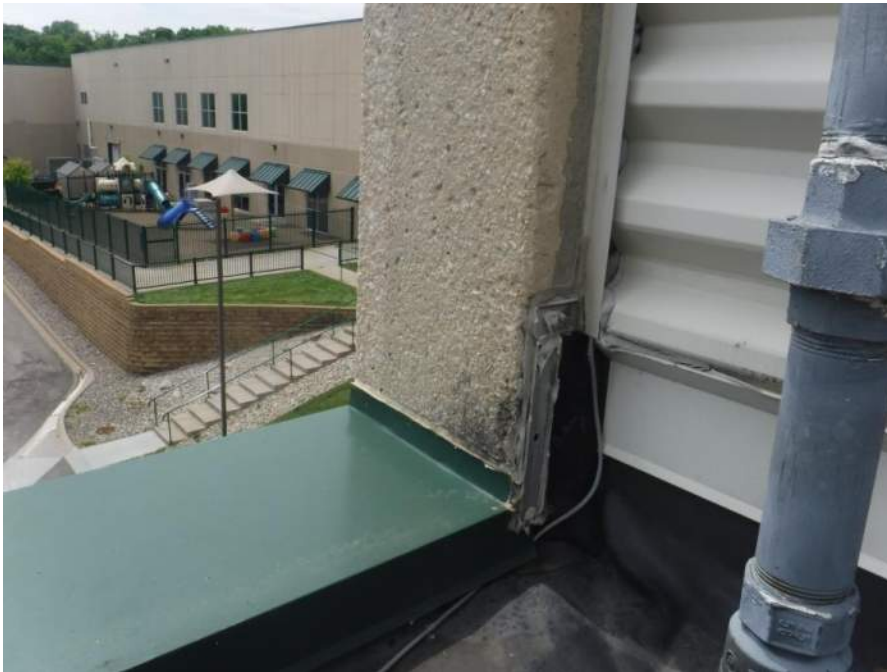
Coping termination to adjacent precast wall, coping end dam is reliant on sealant for water-tightness

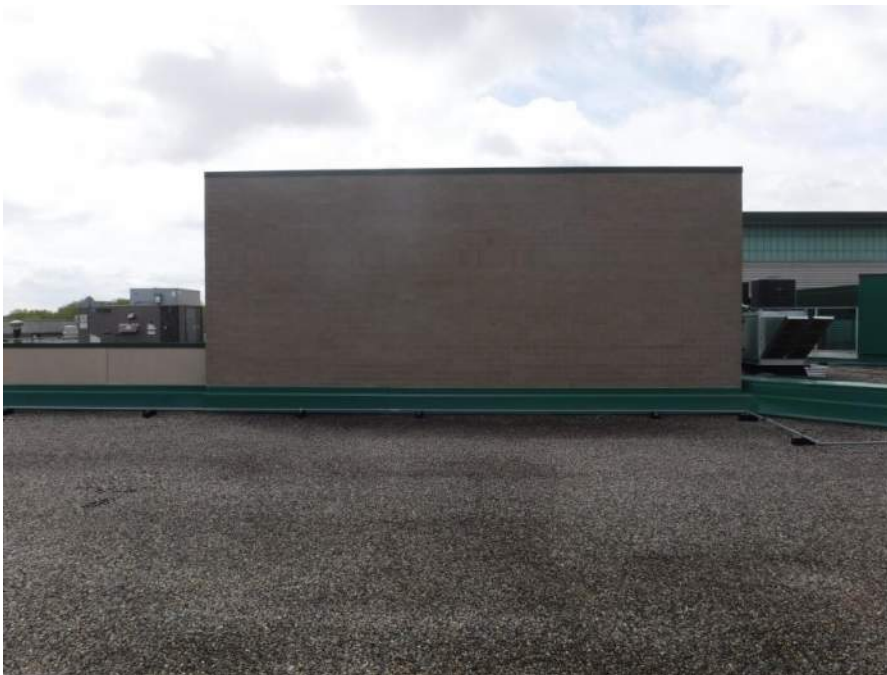
North-facing masonry wall of Rink B penthouse

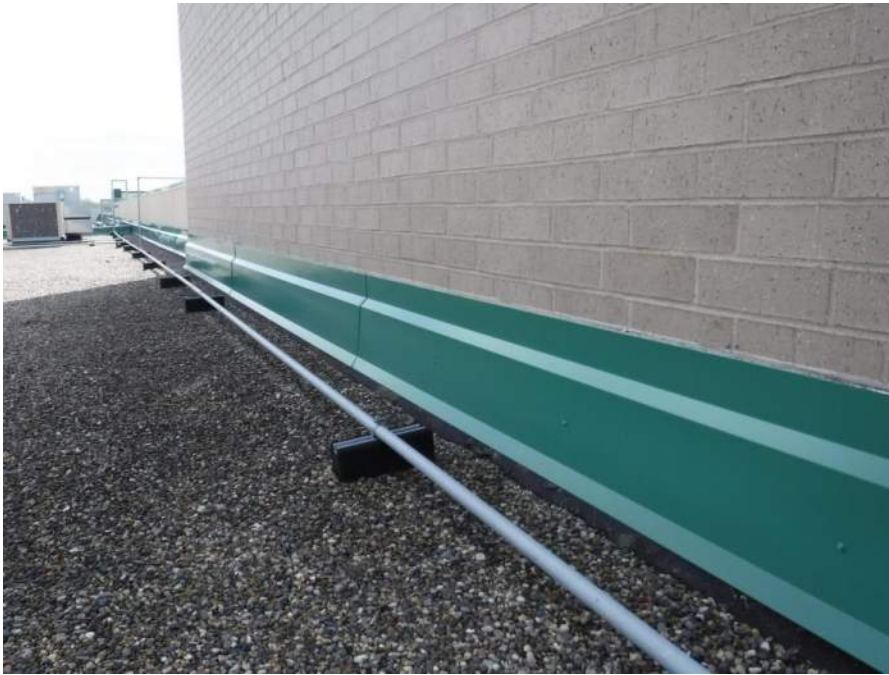
Roof is upturned and sealed to face of masonry veneer and concealed by metal counterflashing with reglet into masonry, no masonry thru-wall flashing above the roof termination

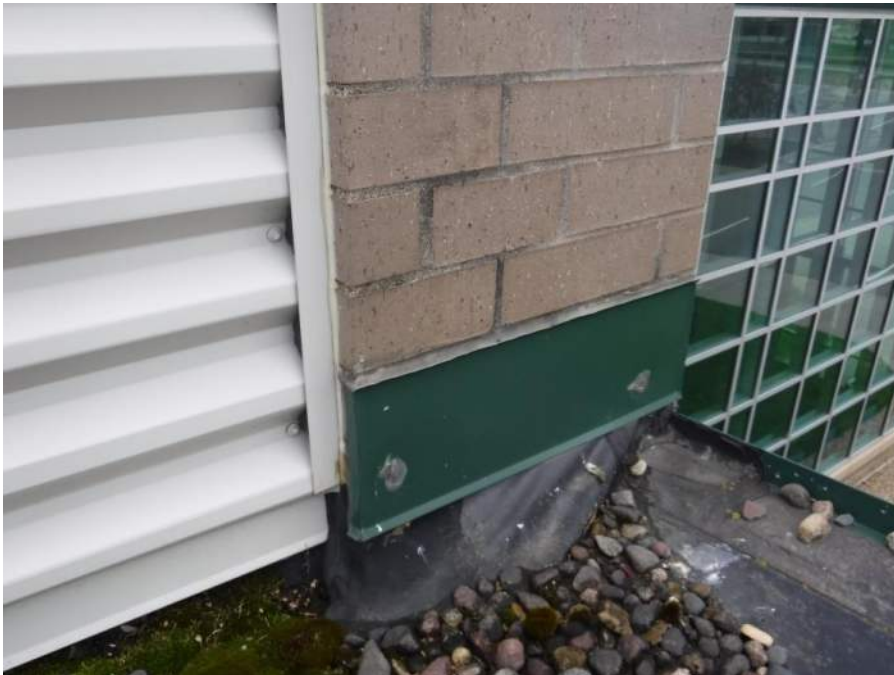
Close-up of previous photo, no masonry thru-wall flashing above the roof termination

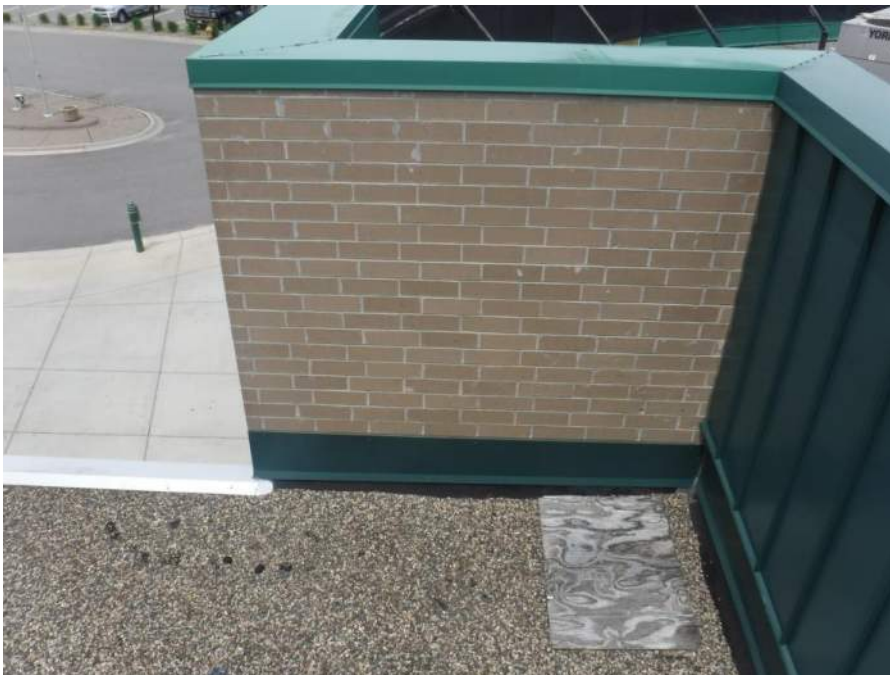
Roof termination to masonry veneer wall at northeast edge of entrance roof with no thru-wall flashing above

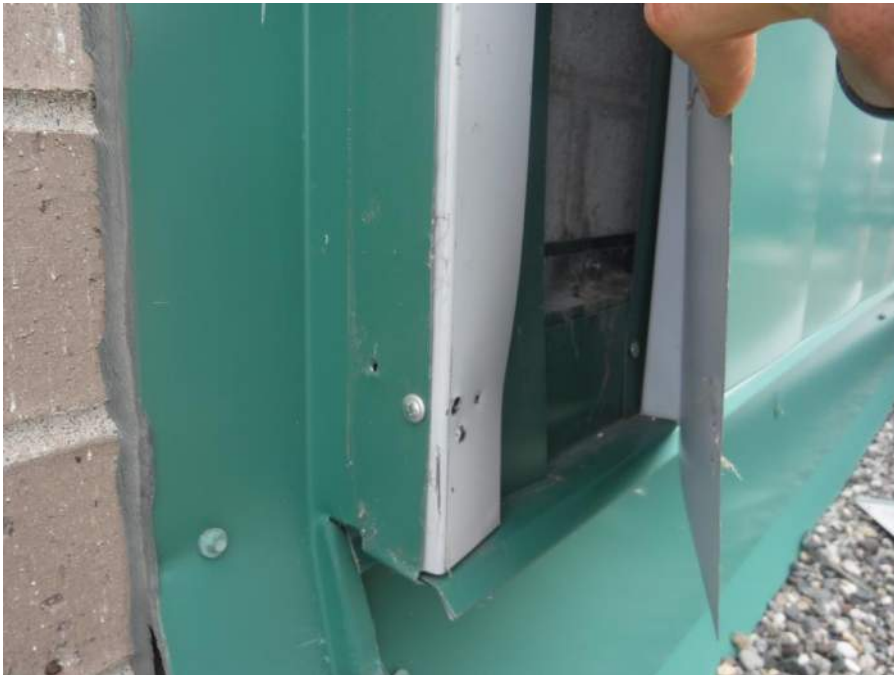
Roof membrane is terminated to face of CMU wall

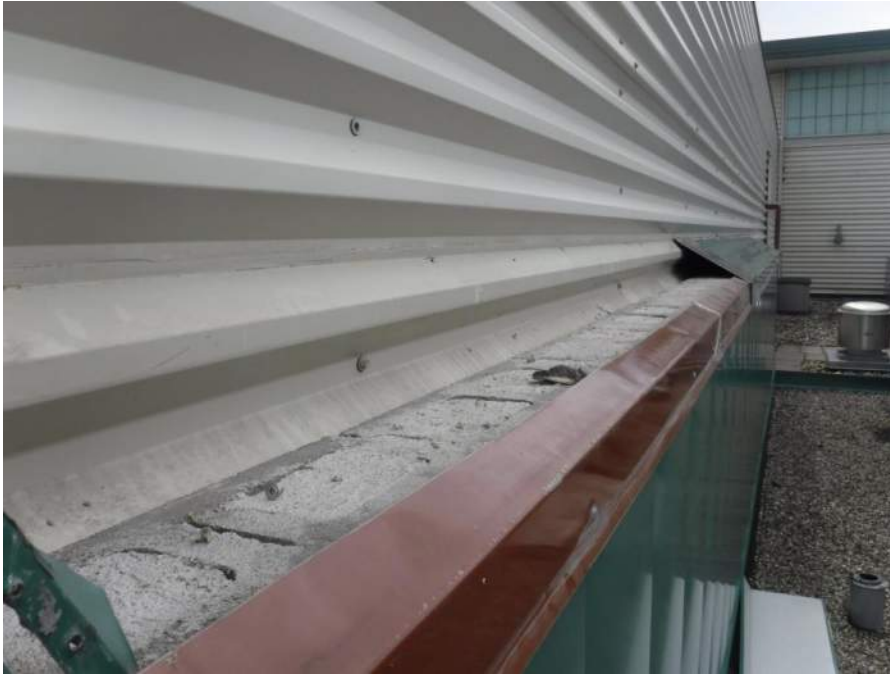
Coping removed from top of CMU wall, coping was sealed to face of corrugated metal panel

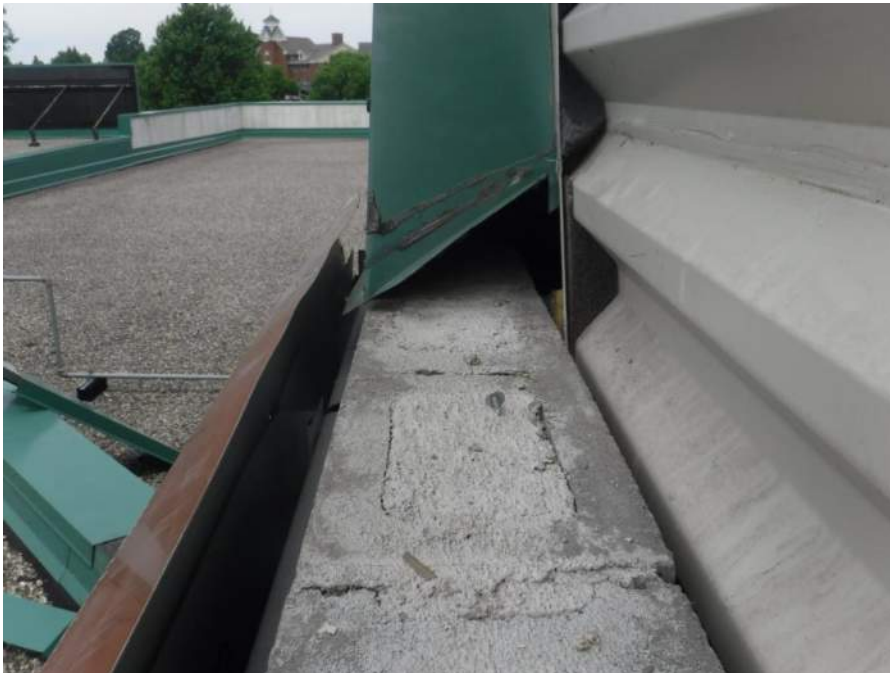
Coping was also sealed to face of adjacent sloped metal panel

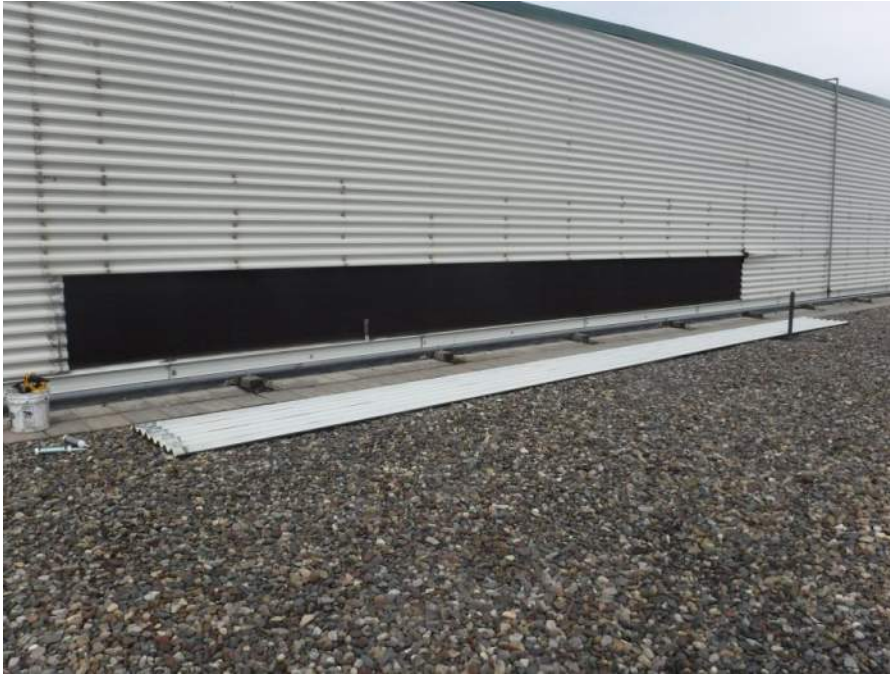
Removed metal panel on east wall of Rink A

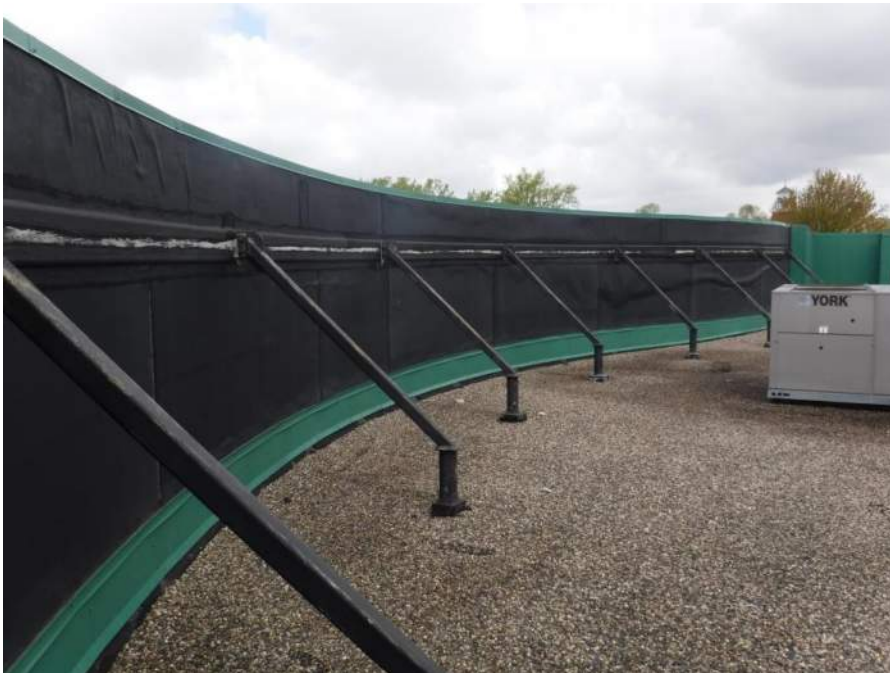
Adhered EPDM membrane cladding on backside of curved parapet of café addition with steel braces

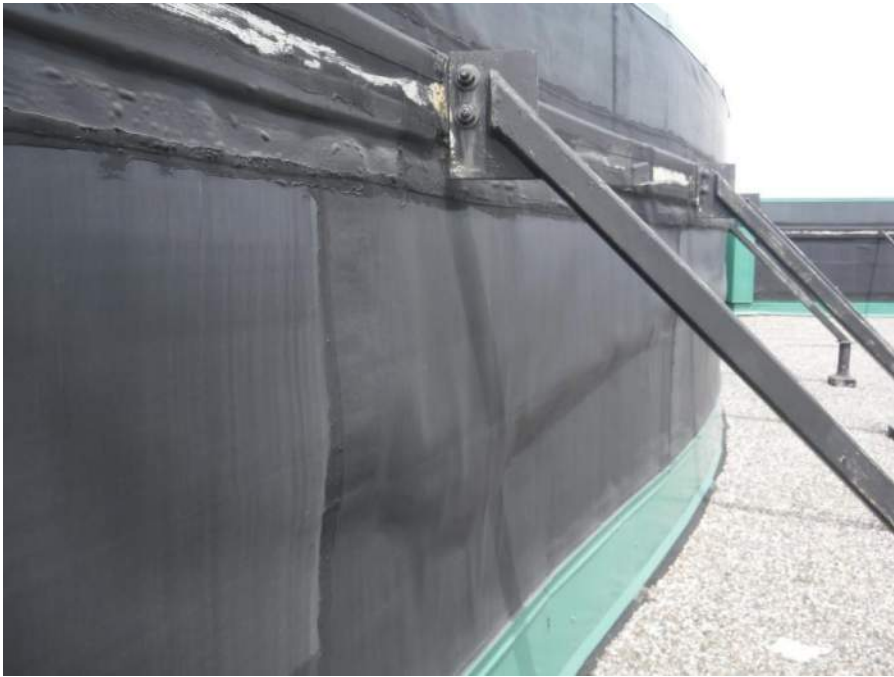
Typical unadhered EPDM membrane

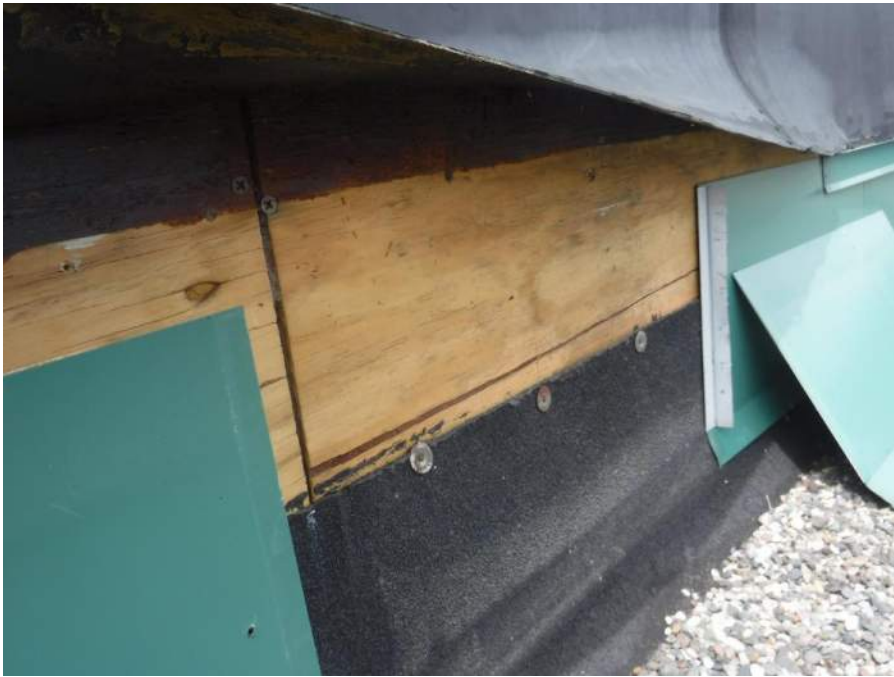
Test opening at base of EPDM clad parapet

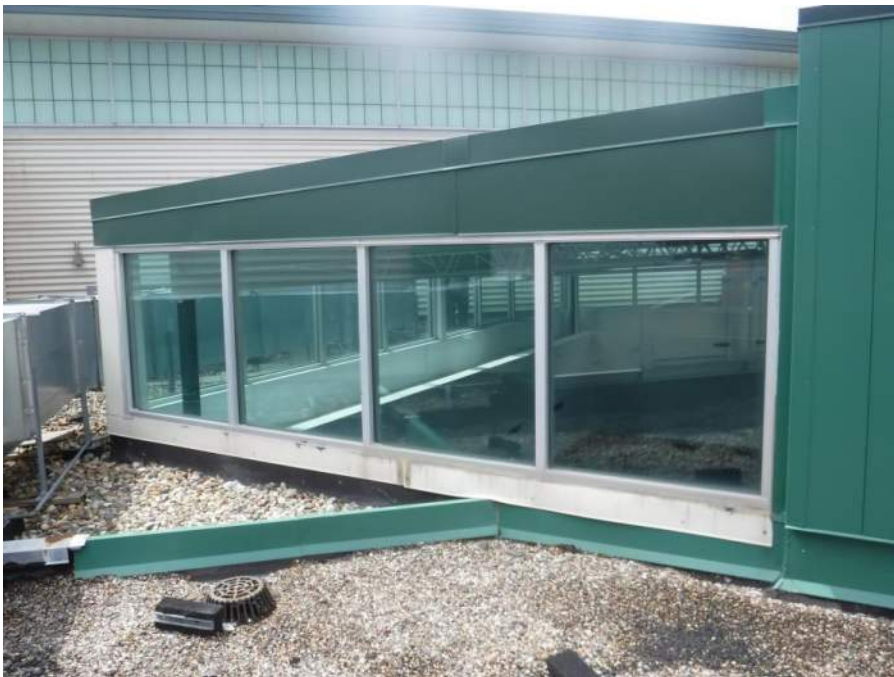
Clearstory windows on northeast elevation of entrance roof

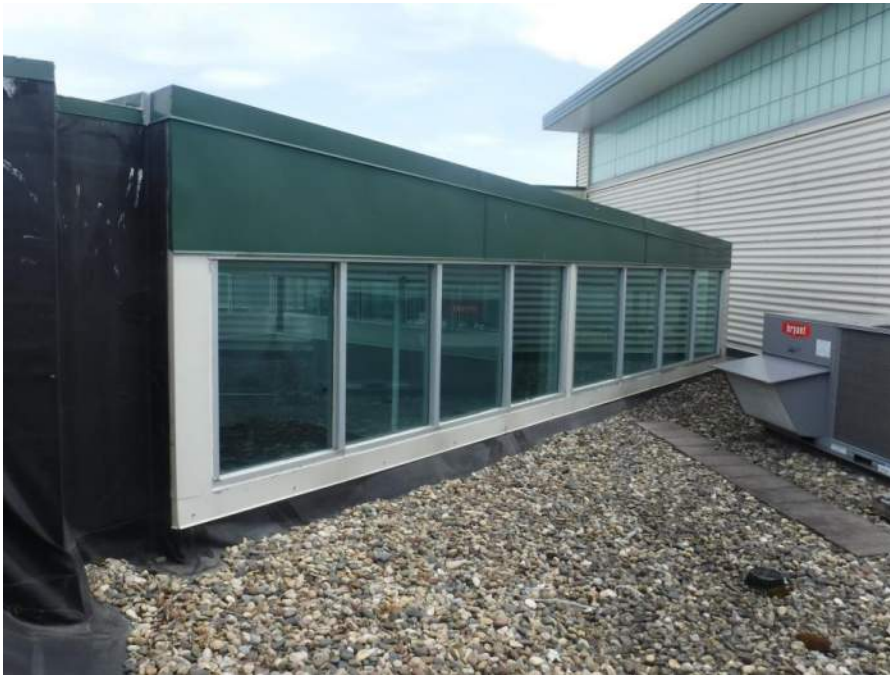
Clearstory windows on southwest elevation of entrance roof

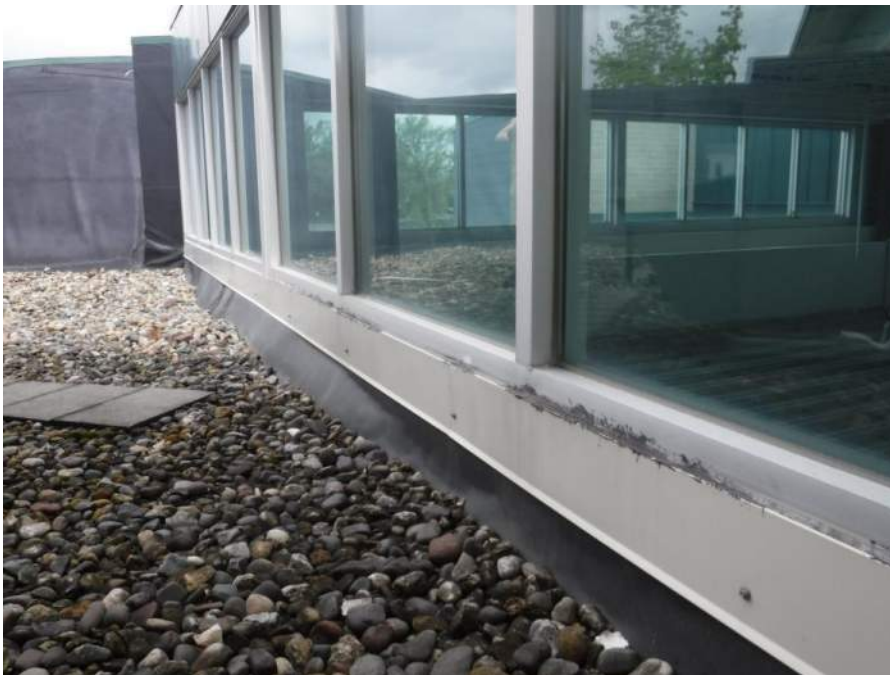
Note different types of sealant applied to joint below sill
